Technical Service Bulletin

Topic	Clicking noises from the left and/or right front corner(s)
Market area	Bentley: worldwide (2WBE),Hongkong-Macau (5HK)
Brand	Bentley
Transaction No.	2052853/7
Level	EH
Status	Archive

Bentayga series

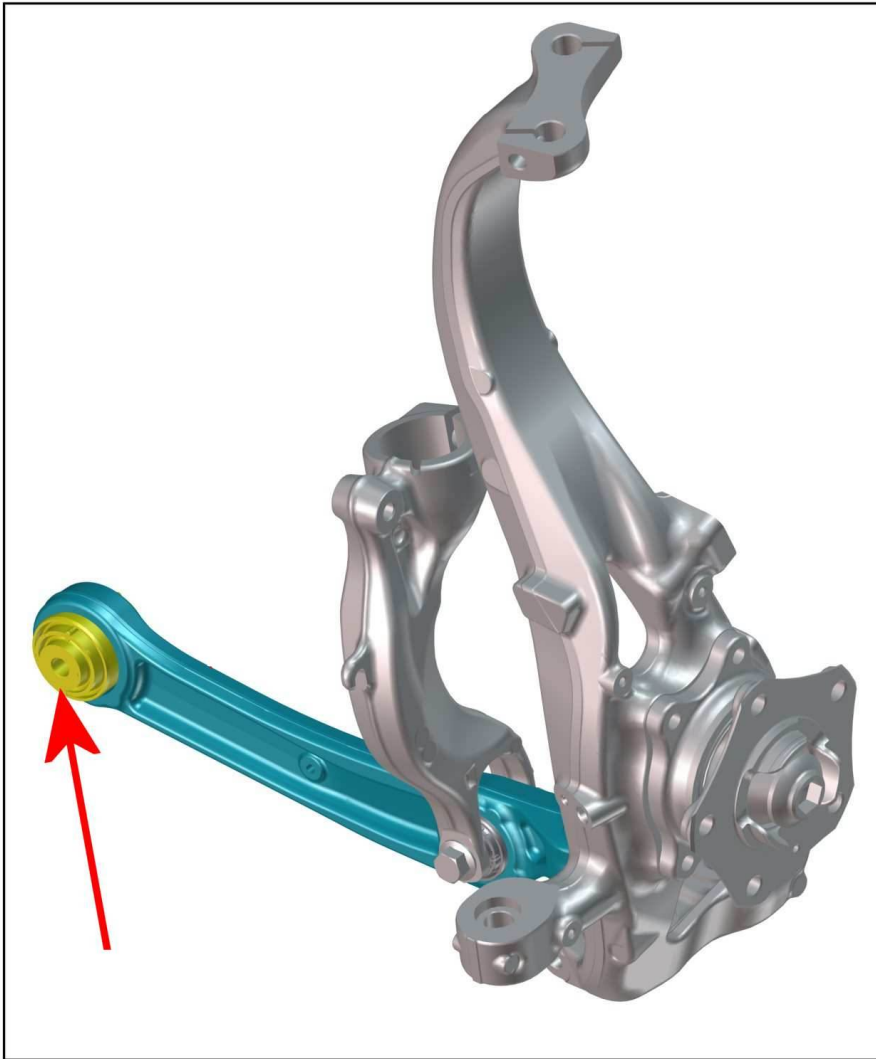
Figure 1

Single click from the front wheel corner(s) when the steering is moved from lock to lock whilst **stationary**

- If so then replace both front lower inner control arm bushes (Figure 1)

IMPORTANT: Please check the vehicle Repair History to confirm the inner bushes have not been previously replaced, if they have been replaced once before, **You must then replace the complete arm. Do Not carry out the bush replacement procedure more than once (per lever)**

IMPORTANT: Prior to starting this procedure ensure you have assembly lubricant part number G 052 566 A2 this must be used when fitting the new replacement bushes, the lubricant should only be used when the bushes are replaced as per the instructions within TPI 2052853/-

Each bush should have 5ml of lubricant applied prior to fitment within the bush, the grease should remain present throughout the fitting/pressing in procedure as the grease aids the fitting process and is also crucial once fitted to eliminate any further noise issues *Please Note that x1 – 100 ml tube will be sufficient for use on 20 bushes (10 vehicles) – Do not order x1 tube of lubricant per each individual vehicle complaint*

1) Remove the left and right hand side Lower suspension levers - Refer to Repair manual Rep.Gr.40

- Once removed refer to the attached document and follow the instructions to replace the left and right hand side lever inner bushes

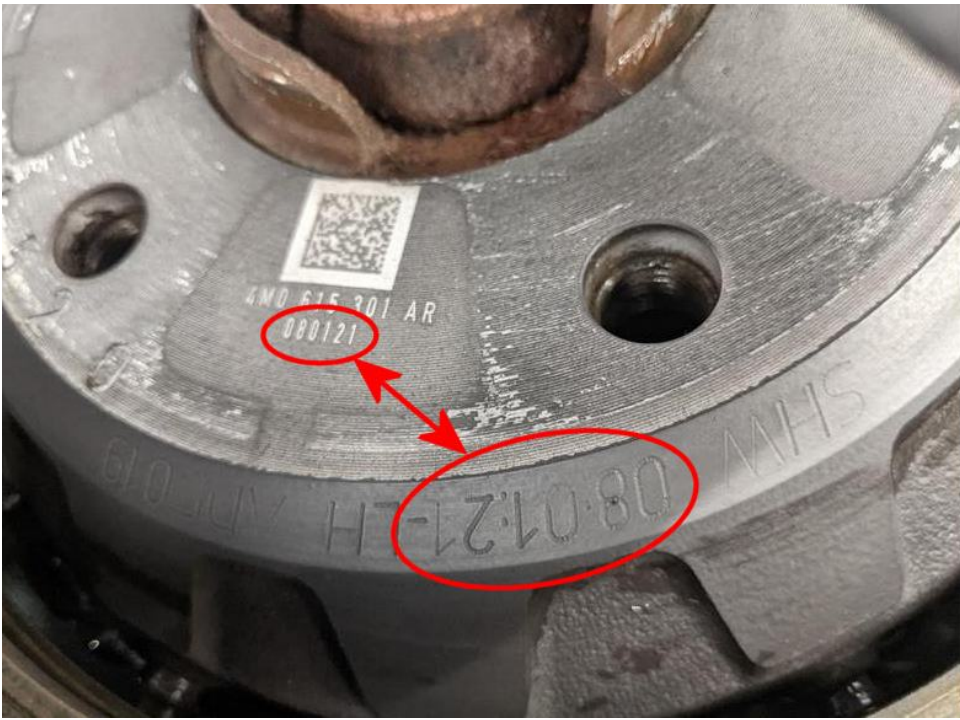
NOTE: The date shown in Figure 2 is 08-01-21

- Raise a new DISS query or respond to an already open query with the following information
 - Clear video of the issue must be attached
 - Photographs of the left and right hand front brake disc date of manufacture stamp as shown in Figure 2
 - Await feedback via DISS before conducting any further work
