Technical Service Bulletin

EXCESSIVE INTERMITTENT MOVEMENT IN DRIVER'S POWER SEAT - REVISED

No: **TSB-21-52A-002**

MODEL: 2007-19 Outlander, 2018-19 Outlander PHEV, 2011-19 Outlander Sport/RVR

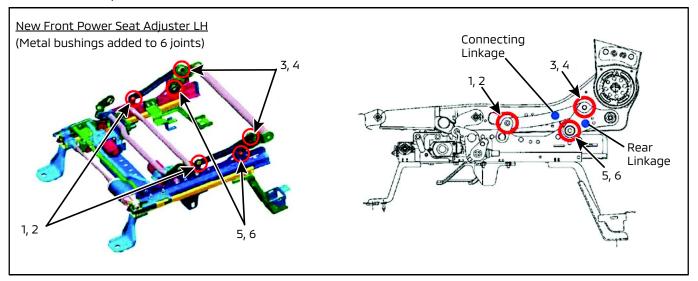
Height adjustment linkages in the seat adjuster assembly may loosen over time with normal driving and allow movement. A new seat adjuster was implemented in production at the supplier from March 2, 2016, and has added metal bushings at the 6 rotational connections on the seat frame, as shown below.

This TSB instructs dealers to replace the seat adjuster assembly and power seat harness in affected vehicles with improved countermeasure parts. Due to a change in the reclining motor, the new longer harness and connector are necessary.

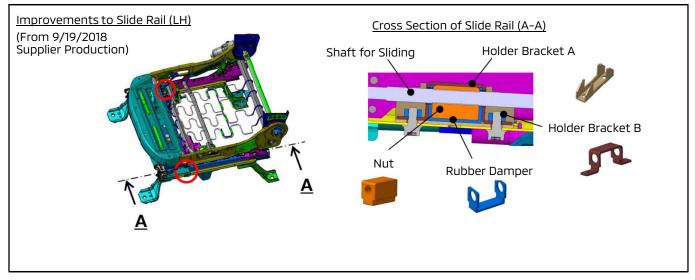
The clearance of the slide rail and rubber damper has also been changed in production at the supplier starting September 19, 2018. Refer to the VINs listed in Affected Vehicles.

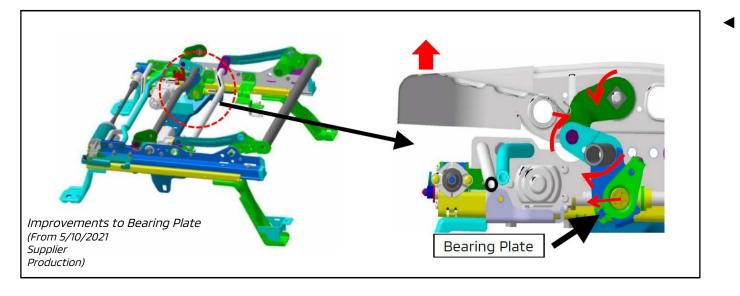
The clearance of the bearing plate hole size has also been changed in production at the supplier starting May 10, 2021. Refer to the VINs listed in Affected Vehicles.
