## MAS002746 (BOL 21-22)

### Door panel damage

**Models:** Quattroporte, Ghibli and Levante

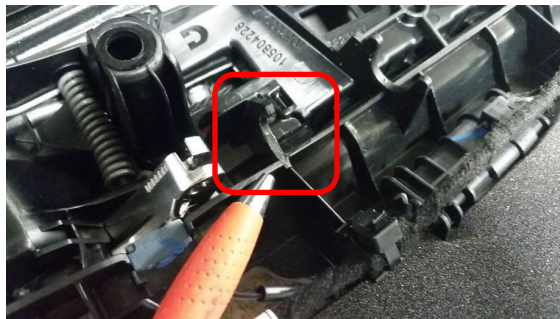
**Issue:** As a result of an analysis carried out on door panels replaced under warranty, a large number of panels have been found with a broken fixing fork that secures the inside handle bowden cable.

**Cause:** The investigations carried out have shown that this breakage can occur when removing the door panel.

**Action:** Maserati has recently developed improved Removal and Refitting procedures in the Repair Manual (9.30.003-02, 9.30.004-02, 9.32.003-02 and 9.32.004-02) that will help to avoid this accidental breakage. It is recommended to follow these updated procedures and as a general rule, always refer to the most up-to-date procedures published in the online Technical Documentation.
