**SIB 66 01 14**

SERVICE ACTION: Keyless Ride Radio Keys - Bulletin 66 001 14 (026)R

Subject: Keyless Ride Radio Keys

Model: K 1600 GTL Exclusive (K48)

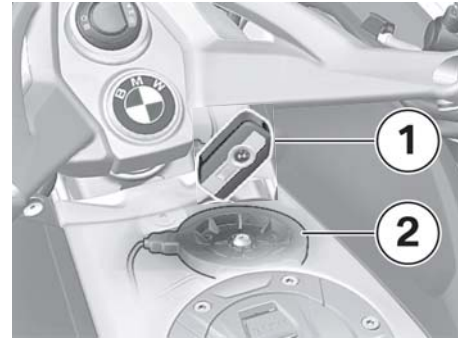
1: Procedure for preparing new radio keys for use (brief test)

Details: BMW Motorrad has ascertained that Keyless Ride radio keys produced before March 28, 2014 have faulty software. This can result in the radio key ceasing to work; resulting in the engine not being able to start. If the radio key stops working while riding, the warning and indicator lamps light up to indicate the fault but the engine will not stop running until it is shut off. The emergency key is not affected by this problem and can be used at any time.

- Move all radio keys out of range of the aerial ring (distance more than 2 meters).
- Hold one of the new radio keys in position over the aerial ring and switch on the ignition. Verify the engine can be started.
- Switch off the engine by means of the Keyless Ride button, not by means of the emergency-off switch (kill switch).
- Wait for 20 seconds with the ignition OFF.
- Hold the second new radio key in position over the aerial ring and switch on the ignition. Verify the engine can be started.

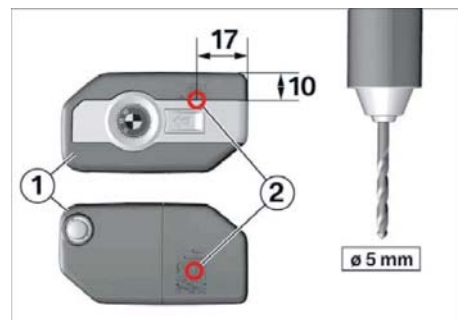
2: Procedure for destroying radio keys with faulty software

In order to avoid the possibility of confusion and prevent the radio keys with faulty software from being returned to customers, both radio keys must be destroyed and disposed of in the appropriate manner. Even radio keys with the faulty software that have always worked faultlessly can fail at any time. Under no circumstances should these keys be handed back to the customer as spares.

- Remove the battery from faulty radio key (1). (see riders manual)
- Clamp the radio key in a bench vice and drill a hole through it at destruction point (2) with a drill bit.

Technical data	
Drill-bit diameter	5mm
Destruction point (2)	17mm x 10mm
