Technical Service Bulletin

48 Noises from the engine compartment are heard inside the vehicle (via the intermediate steering shaft)

48 21 13 2063528/2 November 9, 2021. Supersedes Technical Service Bulletin Group 48 number 21-04 dated June 9, 2021 for reasons listed below.

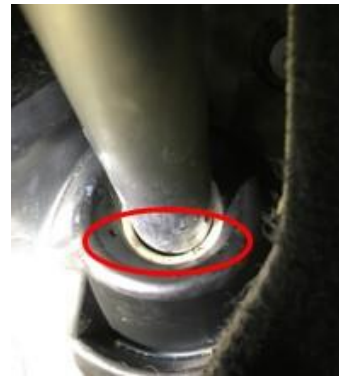
There are multiple causes of noise being transmitted from the engine compartment to the interior of the vehicle. A possible cause of noise being transmitted from the engine compartment is insufficient noise insulation at the opening for the intermediate steering shaft in the bulkhead.

1. Therefore, check whether the sealing boot is seated correctly on the intermediate steering shaft and on the bulkhead without any visible gaps (Figure 1).

Figure 1. Poor sealing on the intermediate shaft.

2. The noise may also be influenced by the height adjustment of the steering wheel.
3. If a similar condition is found in the vehicle, then proceed with intermediate steering shaft replacement following instructions according to the Elsa repair manual, *Chassis >> Suspension, Wheels, Steering >> 48 Steering >> Steering Column >> Steering Intermediate Steering Shaft, Removing and Installing.*
