Technical Service Bulletin

90 Instrument cluster: the Audi Virtual Cockpit displays a colorful vertical line (pixel error)

90 21 22 2064983/1 November 9, 2021.

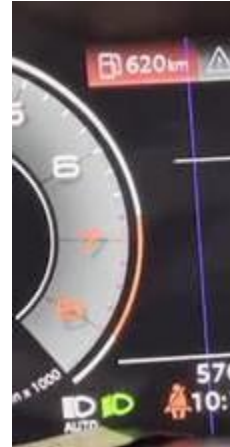
- A red, green or blue continuous vertical line is displayed on the instrument cluster (pixel fault) (Figures 1 - 2).

Figure 2. Vertical line through the instrument cluster display.

There is a hardware issue in Audi virtual cockpit.

2. Please replace the instrument cluster, J285 (address word 0017) according to the Elsa Repair Manual.
