# Technical Service Bulletin

## 91 SOS Warning displayed in instrument cluster, DTC B18BE13 or B18BD13 stored in the telematics control module

91 21 52 2054038/3 November 17, 2021. Supersedes Technical Service Bulletin Group 91 number 19-82 dated August 26, 2019 for reasons listed below.

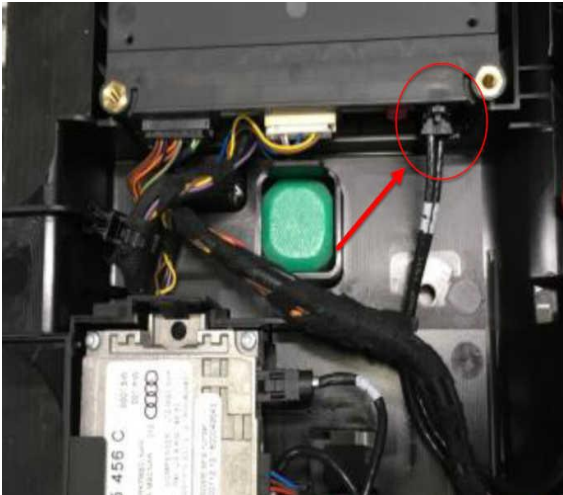
*Figure 1. Telematics Control Module (J949) Connector.*

If the ConBox is not properly seated in its mount before the 4 pole antenna connector is connected, it can lead to the pins in the connector being widened, losing contact between the antenna and the ConBox.

1. Remove the original 4 pole connector including its pins and remove a section of the vehicle's coaxial wiring for the applicable antenna circuit.

Measure the length of coaxial wiring to be removed based on the adapter antenna cable you are using. This will ensure that the removed section is the same length as the adapter antenna cable (000 098 714).

2. Replace the original 4 pole connector and cable with the new connector harness and pins.
3. Before plugging the new 4 pole connector in, make sure that the telematics control module, J949 (address word 0075) is mounted properly in its bracket.

Do not tilt the control module while plugging in the 4 pole connector. Tilting the control module while plugging the connector might damage the new pins.
