60-19-04 - Sunroof Water Leak - Reduced Adhesion Causing Loose Seal (U.S. Only)

Release date: 11/17/2021

Applicable Vehicles					
Model(s)	Year	Eng. Code	Trans. Code	VIN Range From	VIN Range To
Tiguan LWB	2018-2022	All	All	AX_JM000001	AX_NM019254

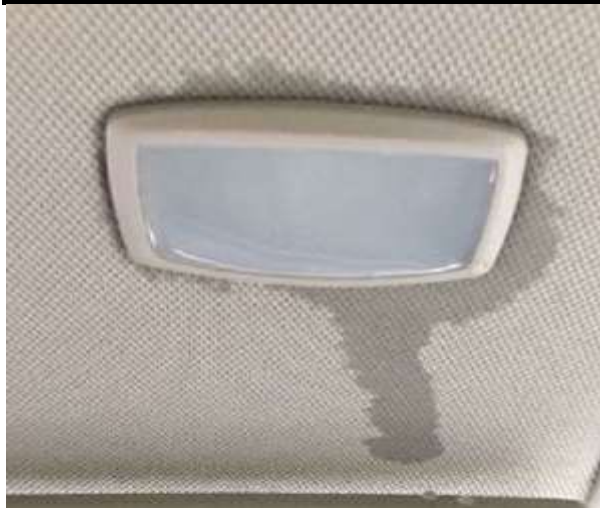
Front headliner area is wet around the vanity light(s), sunroof, and overhead console area due to water entering via the sunroof.

Figure 1: Example of water leak coming from the front vanity light.

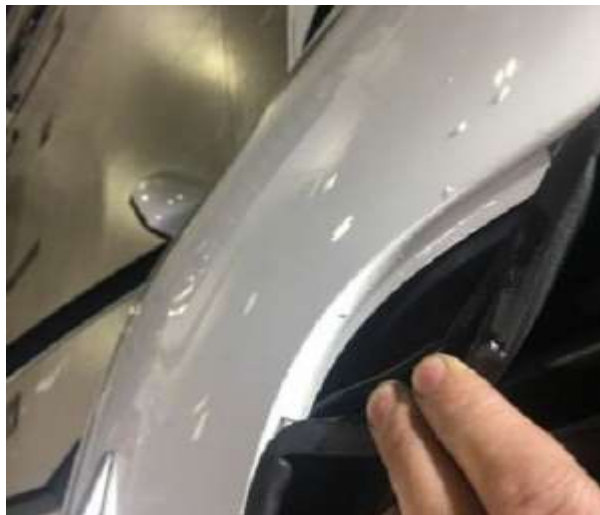
Water leak is due to poor adhesion of the sunroof body side seal to the body.

Figure 2: Example of the sunroof body side seal not having proper adhesion to the body.

- Remove the sunroof frame per ELSA repair instructions, “Body -> Body Exterior -> 60 Sunroof -> Sliding Sunroof -> Sunroof Frame, Removing and Installing” in Elsa.
- Remove the sunroof body side seal per ELSA repair instructions, “Body -> Body Exterior -> 60 Sunroof -> Sliding Sunroof -> Sunroof Seals, Removing and Installing -> Outer seal, Removing and Installing” in Elsa.

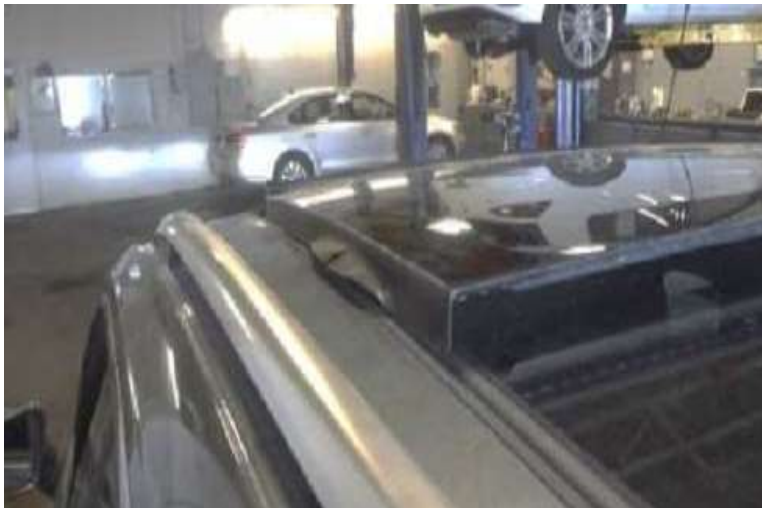
- Visually ensure sunroof panel molded seal and body side seal have no deformation.

Figure 3: Example of the sunroof panel molded seal warped/deformation.

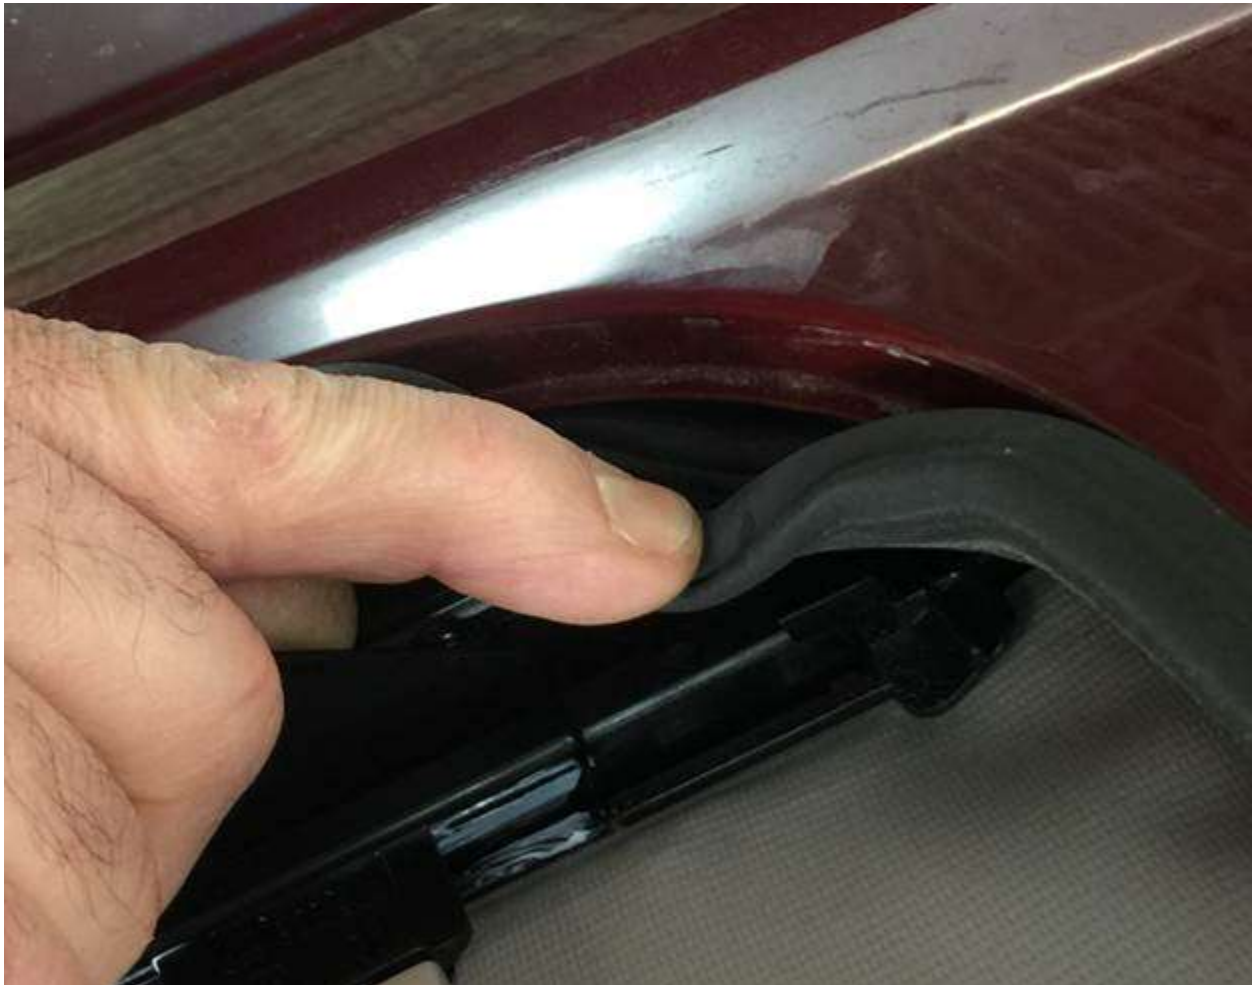
Start by pulling slightly on the body side seal and moving along the seal to confirm proper adhesion of the seal to the body until the seal is completely off. Once the seal has been removed, inspect it for non-adhered sections.

Figure 4: Example of a adhesion issue photo for uploading into WISE.

Take photos of the seal and body sections that were not adhered to the body and upload to WISE for a valid warranty claim.

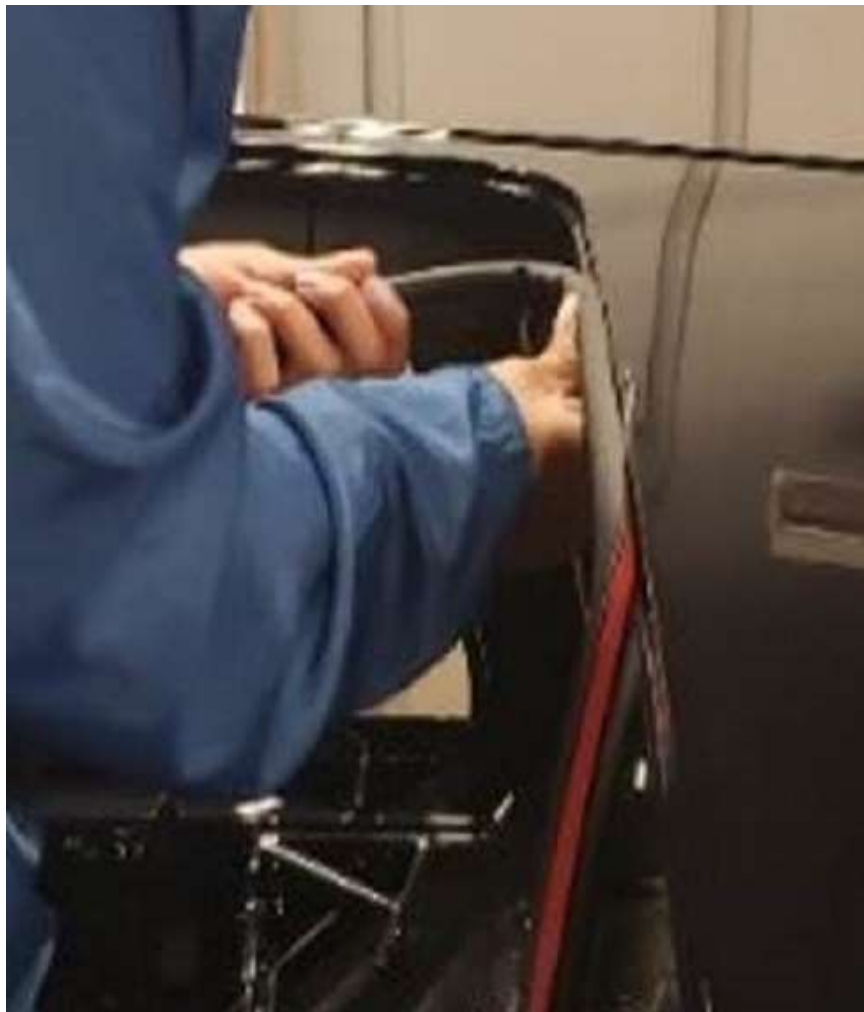
Figure 5: Example of installing the body side seal WITHOUT removing the “red” protective tape.

During the initial installation process DO NOT remove the “red” protective tape on the seal. Remove the “red” protective tape ONLY after the seal has been properly seated (Figure 5).

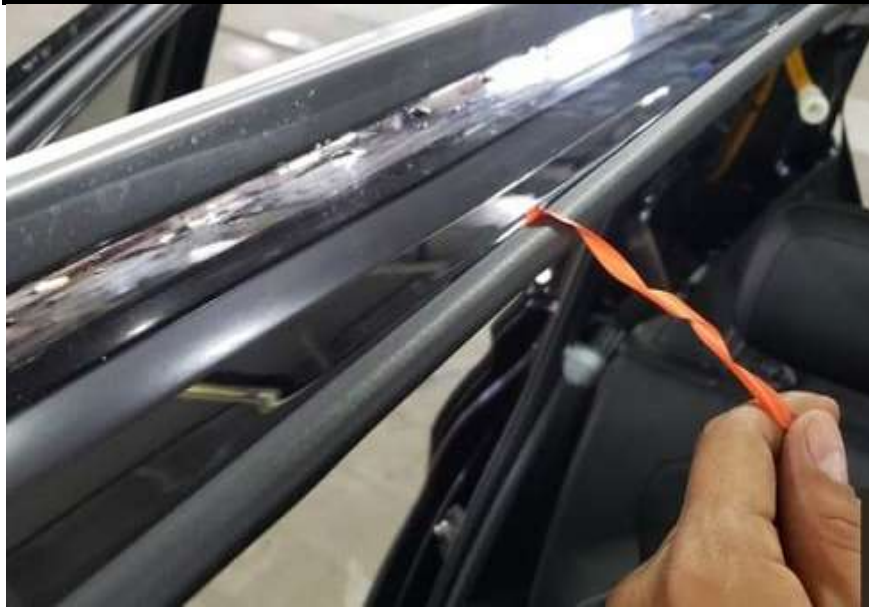
Figure 6: Example of removing the “red” protective tape after seal has been properly seated.

- Continue with the Repair Manual instructions in Elsa to complete the repair.

Take proper care to ensure that the seal is properly adhered to the body, this is a critical step to ensure the issue will be resolved.
