VEHICLE INSPECTION AND UPDATES

AFFECTED MODEL: 2020 1290 SUPER DUKE R

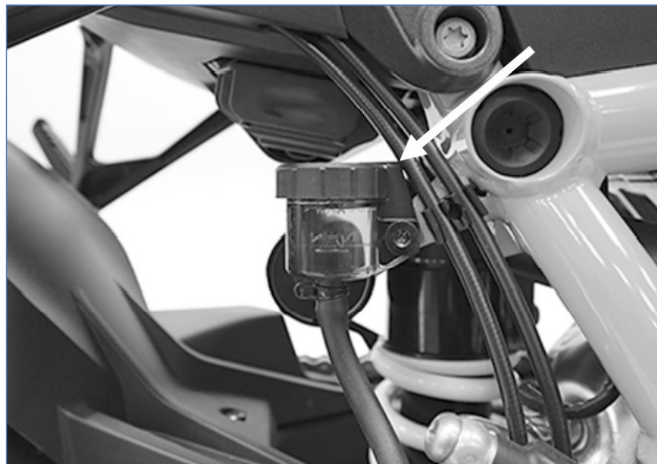
1. Checking the contact point between the cables and the lock washer of the rear brake reservoir

Fig. 1 – Checking the lock washer

- Check the lock washer in the area of the SAC cables (Fig. 1).
- If severe damage to the lock washer (61713069020) of the reservoir is visible, the lock washer should be replaced. **Note:** Create a separate warranty claim with the part number above and 15 minutes working time. The damage must be documented with photos.
- If necessary, turn the reservoir to the rear so there is no contact with the cables. For the tightening torque, see Table 1.

Component	Screw	Torque	Remark
Screw, reservoir, rear brake	M5	3.5 Nm	Medium strength thread lock (e.g., Loctite® 243™)

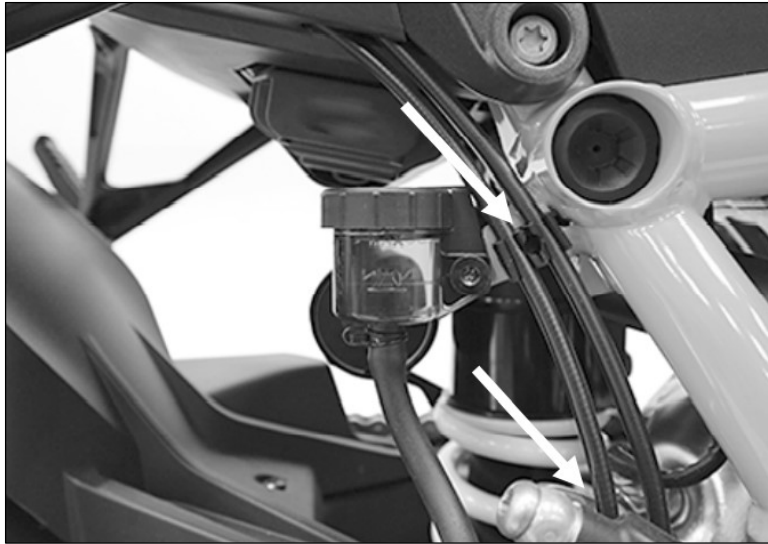
2. Checking the contact point between the cables and the brake line

Fig. 2 – Cables in the area of the brake line

- Check the cable in the area of the brake line (Fig. 2, bottom arrow) for contact.
- Install the new clip next to the reservoir (Fig. 2, top arrow) (0340000900600) and align the cables so that no further contact points are created.

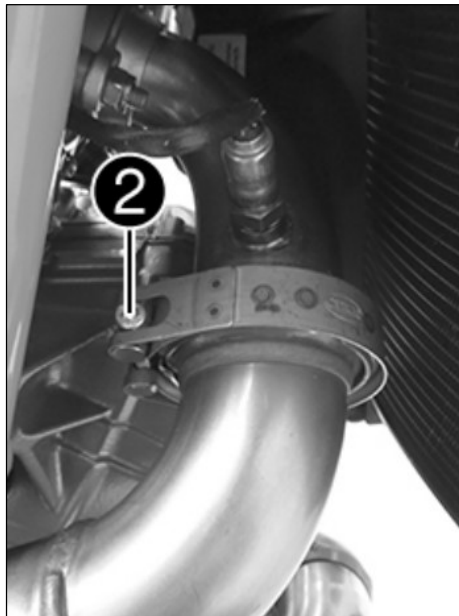
3. Checking the exhaust system screw connection

Fig. 3 – Header bracket, front exhaust system

- Check screw (2) on the front exhaust clamp for the premuffler (Fig. 3).
- Retighten the screw according to Table 2.
- If a leak is detected, the header gasket must be replaced. **Note:** Create a separate warranty claim with the part causing the fault (61705005005 – header gasket 54 mm) and 25 minutes working time. The damage must be documented with photos. Regular inspection of the exhaust clamp screw connection is included in the service schedule for MY 2021.

Component	Screw	Torque	Remark
Screw, premuffler exhaust clamp	M6	10 Nm	Copper paste

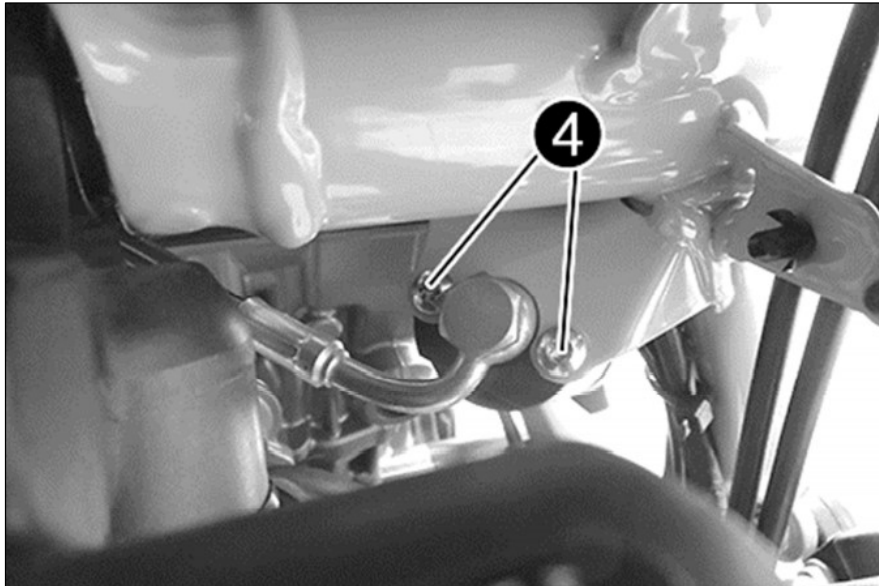
4. Checking the screw connection on the housing of the spring preload handwheel

Fig. 4 – Screws on the housing of the spring preload handwheel

- Remove screws (4) and clean the thread (Fig. 4).
- Mount the screws according to Table 3.

Component	Screw	Torque	Remark
Screw, housing of spring preload handwheel (# 0738050082)	M5	5 Nm	Medium strength thread lock (e.g., Loctite® 243™)

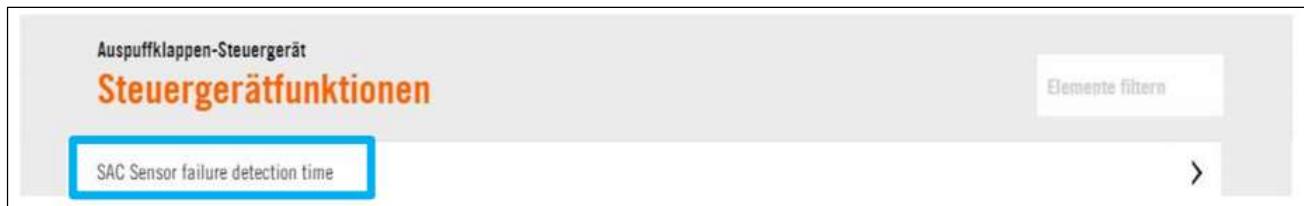
5. Correcting the error detection time of the exhaust valve control unit

Fig. 5 – XC_2 function “SAC Error detection time”

- Connect the motorcycle to the XC_2 diagnostics tool and an external power supply (XCharge).
- Select the “Functions” menu in the control unit under “Exhaust valve control unit”.
- Select the “SAC Error detection time” function (Fig. 5).
- Execute function.
- Select control unit diagnostics to perform the AutoScan.
- Check the control unit for possible errors.
- Delete the fault memory if necessary.
