Technical product information

Topic	Bentayga - Air suspension warning light within the DIP - DTC's P089200 - C104707 - C103B13 - Evident within Address 74
Market area	Russische Föderation (5RU),Australia E04 Bentley rest Asia and Australia (6E04),China 796 VW Import Comp. Ltd (Vico), Beijing (6796),Germany E02 Bentley rest Europe (6E02),Japan E03 Bentley Japan (6E03),Korea, (South) E08 Bentley South Korea (6E08),United Arab Emirates E06 Bentley Middle East and Africa (6E06),United Kingdom E01 Bentley UK (6E01),United States E05 Bentley USA and rest America (6E05)
Brand	Bentley
Transaction No.	2062261/3
Level	EH
Status	Approval
Release date

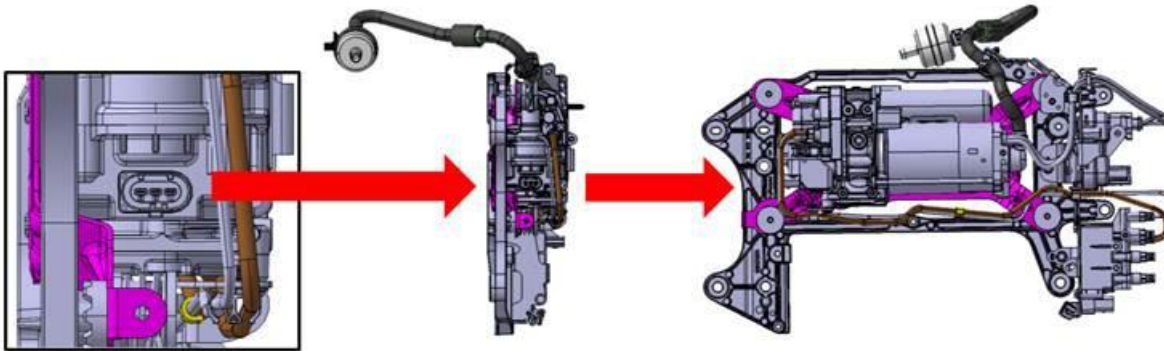
NOTE: NX7 is located as shown in Figure 1 (On the air supply unit/opposite side to the valve block)

- Conduct a wiring integrity check between the Valve block for adaptive suspension control unit (NX7) and the Running gear control unit (J775)
