Technical product information

Topic	Squeaking/creaking noises from the front axle and/or leaks at the lower ball joint/s
Market area	Russische Föderation (5RU),Australia E04 Bentley rest Asia and Australia (6E04),China 796 VW Import Comp. Ltd (Vico), Beijing (6796),Germany E02 Bentley rest Europe (6E02),Japan E03 Bentley Japan (6E03),Korea, (South) E08 Bentley South Korea (6E08),United Arab Emirates E06 Bentley Middle East and Africa (6E06),United Kingdom E01 Bentley UK (6E01),United States E05 Bentley USA and rest America (6E05)
Brand	Bentley
Transaction No.	2065197/1
Level	EH
Status	Approval
Release date

Bentayga

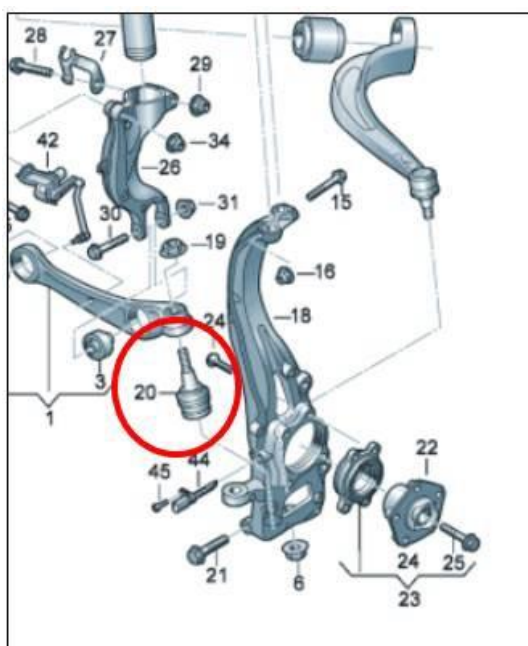
Figure 1

The noises can be assigned to the lower ball joint on the left and/or right side (Figure 1 - item 20).

Leak at the boot of the lower ball joint on the left and/or right side (Figure 1 - item 20) is visible however the boot is undamaged.

1) Referring to Rep.Gr 20 - Replace the left and/or right side lower ball joint

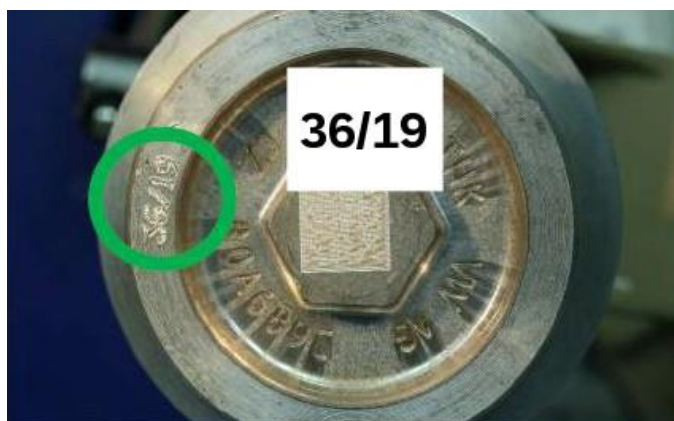
Make sure that the production date of the new ball joint is 36/19 or later (see date code example circled in Figure 2 - Week 36 of 2019).
