Instructions for navigating the document

NEW TOPICS 3

NEW TOPICS

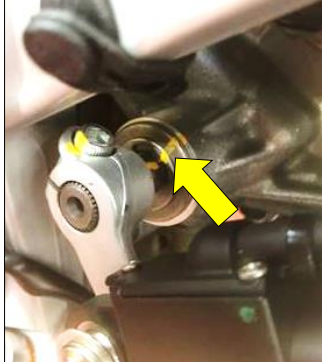
2	<p><u>ONLY</u> <u>Panigale V4</u> <u>(all versions)</u> <u>Streetfighter V4</u> <u>(all versions)</u></p> <p>Introduction of gear selector shaft certification</p>	Gear selector

<p>We have received some isolated reports of a possible loss/absence of the snap ring (A) of the gear selector shaft. We would like to inform you that an additional certification on all Desmosedici Stradale engines between snap ring, washer, and crankcase at the outlet of the gear selector shaft has been added along the production line. The first engine serial number with this new certification is ZDM1100WC #001513#.</p> <p>Upon the first workshop service, you are thus invited to check for the presence of the snap ring (A) on all engine serial numbers preceding the one specified above.</p> <div data-bbox="1771 1066 2197 1433">

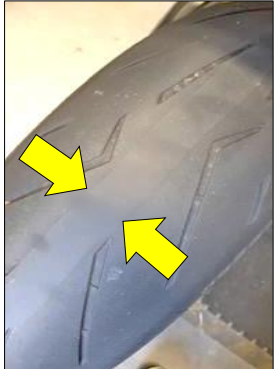
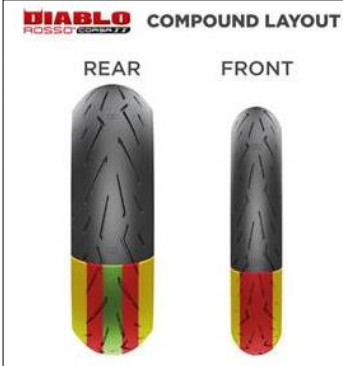
8	<p>Possible formation of a well-marked "band" in correspondence with the central area of the Pirelli Diablo Rosso Corsa II rear tyre</p>	<p>Pirelli Diablo Rosso Corsa II rear tyre</p>

<p>We have received some isolated reports of the appearance of a "band" in correspondence with the central area of the Pirelli Diablo Rosso Corsa II rear tyre.</p> <p>We would like to inform you that, since these are extremely sporty tires with 5 different compound zones at the rear, it can happen that, depending on the type of use of the motorcycle, they wear out in a different way causing the above mentioned phenomenon to occur; sometimes this occurs on the shoulder area, sometimes in the central area but, in general, it is a purely aesthetic phenomenon that does not affect the performance of the tyre itself.</p>

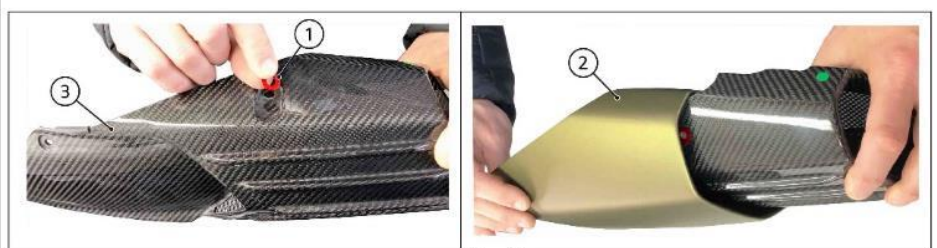
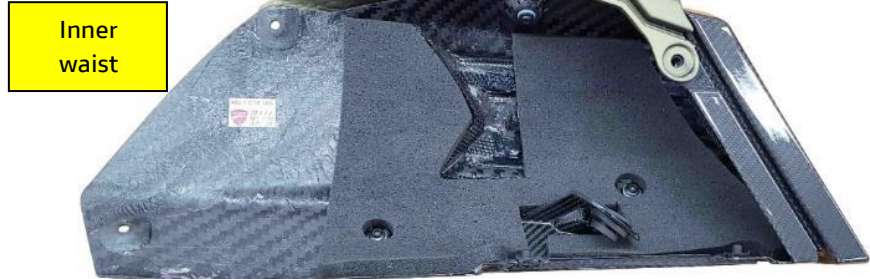
<p>We have received some isolated reports about a possible indentation of the RH and/or LH outer cover of the air conveyor.</p> <p>To avoid this phenomenon, it is necessary to position washer (1) 4x14x1 Part no. 85240171A between outer cover (2) and carbon air conveyor (3) in the upper fixing point, as shown in the figure.</p>

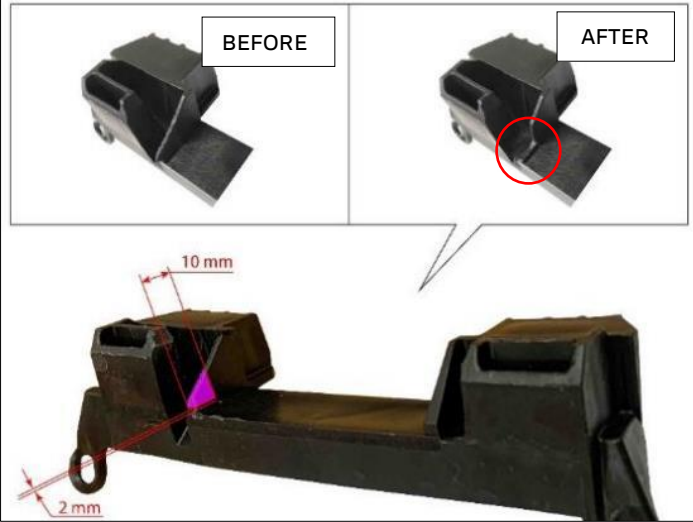
<p>When mounting the rider seat in "high configuration", an excessive gap can be seen between the lower trim and the RH side panel. This is due to interference between the central riser and its support. To avoid such interference and therefore improve the coupling between the rider seat and the side panel, it is necessary to:</p> <ol style="list-style-type: none"> 1) Remove the center riser from the seat; 2) Working on the RH side support, remove the excess material with a cutter, as shown in the figure. 3) Reinstall the center riser to the seat.

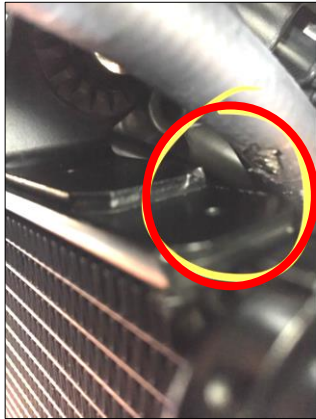
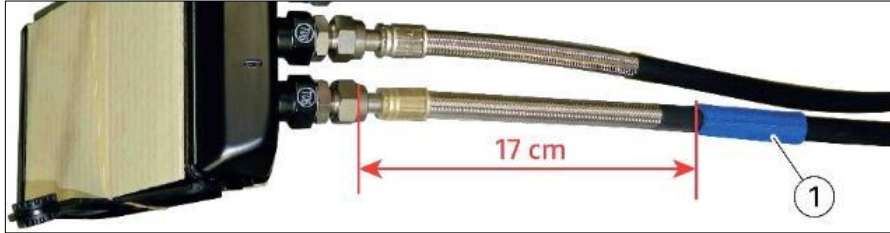
no.	Symptom	Subject	Photo	Notes and Indications - Corrective action
3	<p><u>ONLY</u> Multistrada 950 MY 17-20 Multistrada 1200 MY 15-17 Multistrada 1260 MY18-20 (all model versions)</p> <p>Possible superficial damage to the oil cooler return pipe</p>	Oil cooler pipes

<p>We have received some isolated reports of possible surface damage to the oil cooler return pipe due to rubbing with the top of the coolant radiator, over time. <u>This phenomenon is purely aesthetic and does not affect the correct operation of the system.</u> We inform you that for the models:</p> <p>a) Multistrada 1260: starting from the frame number ZDMAC03AAAKB011354 (on 27/05/2019) the anti-abrasion sheath (1) part no. 4601H701A has been introduced on the oil cooler return pipe, positioned at a distance of 17 cm measured from the upper end of the fitting. (This solution is also applicable to all Multistrada 1200 versions Model Year 2015-2017).</p>

<p>b) Multistrada 950:</p> <ul style="list-style-type: none"> - starting from the frame number ZDMAD00AAKB002259 (on 10/05/2019) the anti-abrasion sheath (1) part no. 4601H701A has been introduced on the oil cooler return pipe, positioned at a distance of 17 cm measured from the upper end of the fitting; - starting from the frame number ZDMAD00AALB005691 (on 12/03/2020) the longer fitting (2) part no. 81510391A has been introduced at the oil return pipe outlet from the cooler.

<p>We ask you to always check the condition of the oil cooler return pipe, and to replace it ONLY if the rubber sheath is damaged and the metallic braided hose can be seen. Follow the assembly notes indicated above according to the reference model. The spare part catalogue has been updated.</p>

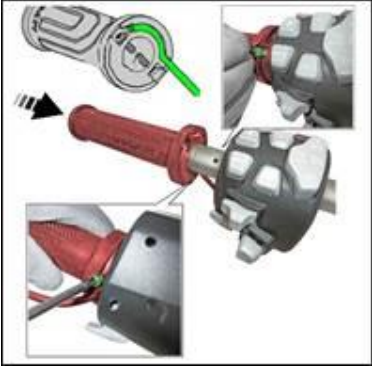
<p>We have received some reports about heated handgrips that have not been installed correctly and so the cable between the handgrip and the switch may be pinched.</p> <p>We kindly ask you to always follow the instructions provided on the DCS under the “accessories catalogue” section or in the model presentation bulletin (SRV-SRB-20-049) and to <u>comply with the correct orientation of the cable and handgrip</u> as shown in the figure.</p>

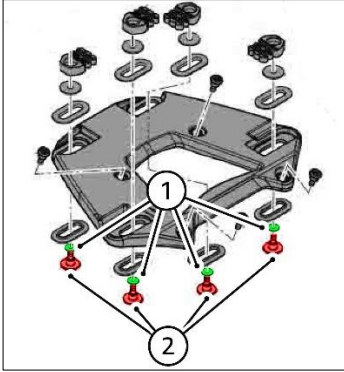
8	<p>ONLY <u>Multistrada V4</u> <u>(all model versions)</u></p> <p>Possible incorrect operation of the swinging system - Top Case accessory kit part no. 96781531AA</p>	Top Case Part no.96781531AA

<p>We inform you that the first Top Case accessory kits part no. 96781531AA delivered may not operate correctly with the swinging system, which may seem "too braked". To improve this condition, it is possible to insert 4 copper washers (1) part no. 85250231A on the 4 screws (2) retaining the bottom plate to the top one.</p> <p>For a better understanding of the assembly procedure of the Top Case accessory kit, a video has been made which can be viewed at the following link: https://youtu.be/DVEHKVvdKQI.</p> <p>All Top Case kits in stock will be restored by February 2021.</p>

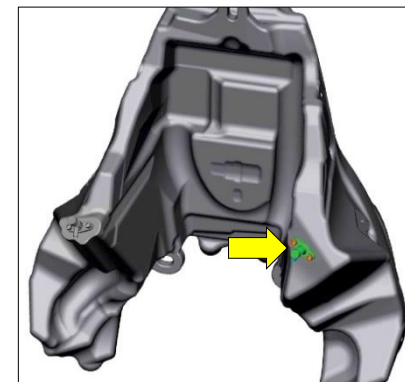
18	<p>ONLY <u>Multistrada V4</u> <u>(all model versions)</u></p> <p>Incorrect residual fuel in the tank</p>	Fuel tank	-	<p>In some cases, we have found that the tap on the right-hand side of the fuel tank is completely closed instead of open; this leads to an incorrect remaining range when there are only a few liters of fuel in the tank (fuel reserve conditions).</p> <p>If the above-mentioned event occurs, we ask you to ensure that the tap on the right-hand side of the fuel tank is fully open</p>

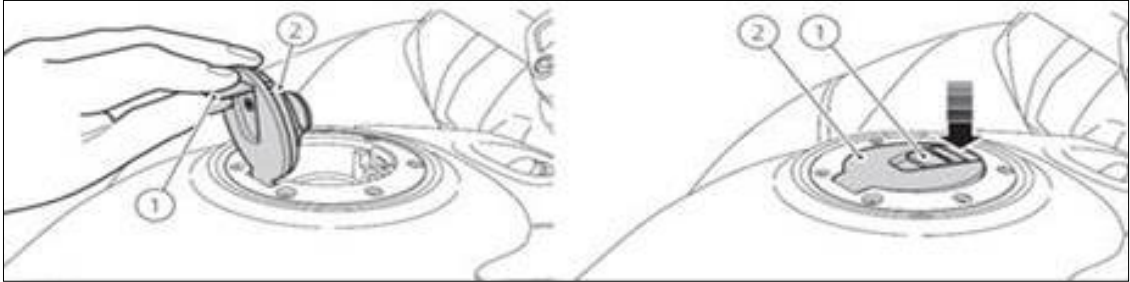
<p>We have received a few isolated reports concerning the hands free fuel cap part no. 96681021AA that proves difficult to open and/or close. DO NOT REPLACE THE FUEL TANK CAP.</p> <p>Hands-free tank filler plug The hands-free tank filler plug allows the cap to be opened during refuelling without using a key.</p> <p>Opening To open the cap, the suitable flap must be lifted within 50 seconds of turning the vehicle off (key off). During those 50 seconds, the cap can be opened a maximum of 5 times. If a new opening is desired, the key must be turned on and then back off (key-on >> key-off).</p> <p><u>Caution: the opening flap must be operated gently. Excessively fast movements may impair the cap opening, even though the attempt will still be counted among the 5 available.</u></p> <p>Information on instrument panel The instrument panel has an icon indicating “fuel cap open”. If the instrument panel is turned on (key-on) while the cap is open, the icon will be active.</p> <p>Closing To close the cap, use your fingers to push it in fully home.</p> <p><u>Caution: After refuelling, always ensure that the cap is correctly positioned and closed and that the corresponding icon on the instrument panel is off.</u></p>

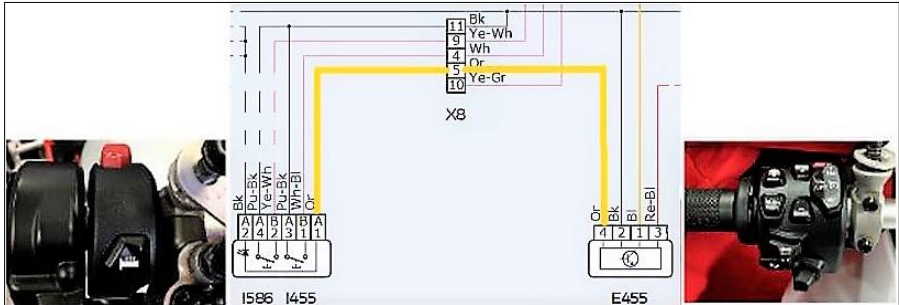
<p>We have received some reports on the right-hand handlebar control switches replaced under warranty - which we have subsequently found to be correctly operating - due to backlighting problems.</p> <p>In case of backlighting problems on the right-hand handlebar control switch, we would like to ask you to carry out the following check before replacing the whole switch:</p> <ul style="list-style-type: none"> • Disconnect the connector from the right-hand switch • Using a multimeter [preferably with thin test prods to ensure good electrical contact with the internal pins (insert two metal needles if necessary)] and with the ignition on, measure the voltage present across pins 1 and 2 on the connector on wiring side • If the voltage measured is approximately equal to battery voltage value (around 12-13V), the absence of backlighting is due to an internal problem of the switch, which must therefore be replaced. • If the measured voltage is zero or very low, the problem is not inside the switch, which therefore does not need to be replaced • Since the backlighting is powered by the left-hand switch, in this case: <ol style="list-style-type: none"> 1. Disconnect the connector from left-hand switch 2. Use a multimeter to check for signal continuity across pin 4 of the left-hand switch connector (wiring side) and pin 2 of the right-hand switch connector (wiring side) <div style="text-align: center;">

</div> <ol style="list-style-type: none"> 3. If there is no continuity, the problem is probably due to an open circuit within the wiring or on the pins of one of the two connectors 4. If continuity is present, the problem could be directly caused by the left-hand switch not supplying power correctly: please report the problem through a dedicated Youtech request

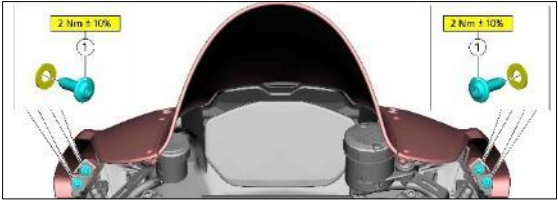
<p>We received some isolated claims about the possible breakage of the top fastener retaining the LH side half-fairing to the headlight fairing.</p> <p>During PDI and whenever removing the side half-fairings, we remind you to pay utmost attention to the tightening of the 2 screws M5x0.8 (1) retaining the upper LH and RH half-fairings to the headlight fairing; always comply with the specified tightening torque of 2 Nm ± 10%.</p>

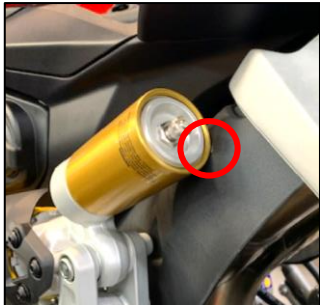
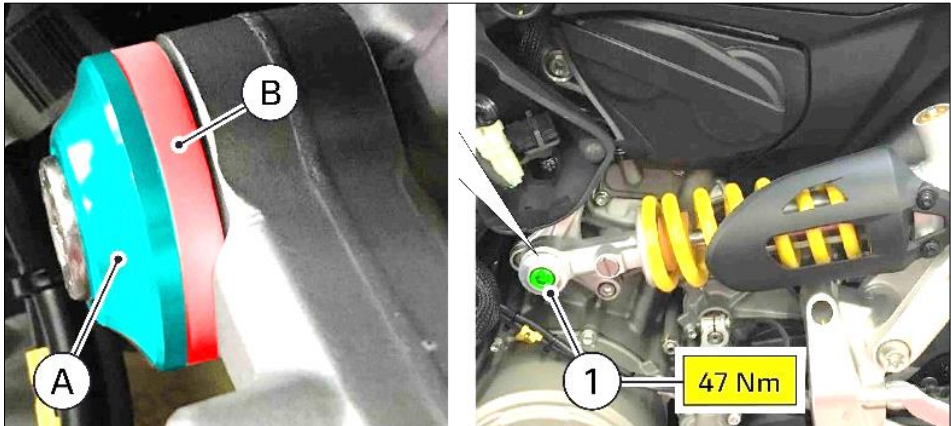
16	Possible switching on of OBD warning light on instrument panel	Connector Engine ECU

<p>We have received reports concerning the switching on of the OBD warning light on the instrument panel and error validation:</p> <ul style="list-style-type: none"> • P2100 ATT injection control unit, Front bank ETC electronic throttle motor power stage (Cyl 1-2) [Open circuit] • P210A ATT injection control unit, Rear bank ETC electronic throttle motor power stage (Cyl 3-4) [Open circuit] <p>If your motorcycle is in these conditions, we ask you to check the status of the engine ECU connector as there may be moisture inside it and to fill out a Youtech service request attaching photos of the connector and specifying if the motorcycle has been washed with a pressure washer (with or without side fairings).</p>

<p>We would like to inform you that starting from the frame number ZDMHAATW2MB003762, a spacer and a Teflon anti-rotation washer have been introduced at the front fixing screw of the shock absorber to prevent possible contact between the rear shock absorber reservoir and the vertical head manifold head guard. The contact results in a cosmetic defect only.</p> <p>In case of complaints from the Customer, it is possible to proceed with the installation of spacer part no. 7111D981AA (A) and washer part no. 7131E352A (B), as shown in the figure.</p> <p>We remind you to always apply the screw M10x45 (1) with Shell GADUS S2 V220 AD 2 grease and to tighten the screw to the new torque of 47 Nm (the previous tightening torque was 45 Nm).</p>
