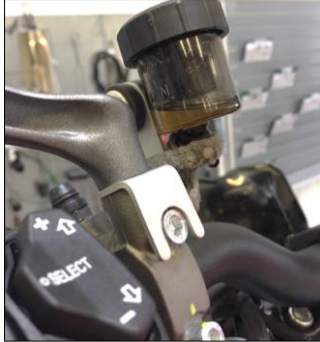
no.	Symptom	Subject	Photo	Notes and Indications - Corrective action
6	<p><u>ONLY</u> <u>models equipped with</u> <u>hydraulically controlled</u> <u>clutch lever</u></p> <p>Possible reduction of the clutch fluid level inside its reservoir</p>	Hydraulic clutch control

<p>We received a few claims concerning a reduction of the clutch fluid level inside its reservoir. We would like to inform you that it is not sufficient to carry out the bleeding procedure or top up the clutch fluid inside the reservoir. We suggest, at a preliminary stage, to check:</p> <ul style="list-style-type: none">• the play between the clutch master cylinder and the lever• if the clutch pushrod is worn or damaged in the area of contact with the clutch slave cylinder (ball)• the condition of the clutch slave cylinder protective diaphragm, which must not be torn. <p>According to our analyses, this phenomenon is due to a DOT4 leakage from the primary seal of the clutch slave cylinder (missing fluid in the reservoir builds up in-between the clutch slave cylinder diaphragms); in some cases, this phenomenon is also accompanied by wear of the clutch pushrod. We therefore ask you to replace the slave cylinder with a new part no. 19540091D featuring a new gasket in order to prevent the phenomenon described above.</p> <p>If the clutch pushrod is damaged as shown in the figure, replace it as well.</p> <div data-bbox="1227 719 2024 1018">

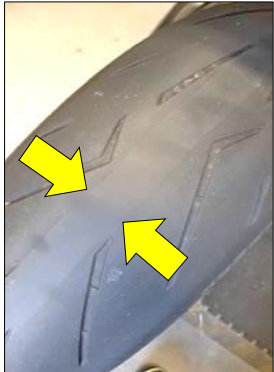
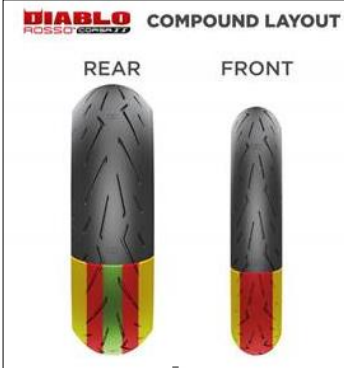
8	<p>Possible formation of a well-marked "band" in correspondence with the central area of the Pirelli Diablo Rosso Corsa II rear tyre</p>	<p>Pirelli Diablo Rosso Corsa II rear tyre</p>

<p>We have received some isolated reports of the appearance of a "band" in correspondence with the central area of the Pirelli Diablo Rosso Corsa II rear tyre.</p> <p>We would like to inform you that, since these are extremely sporty tires with 5 different compound zones at the rear, it can happen that, depending on the type of use of the motorcycle, they wear out in a different way causing the above mentioned phenomenon to occur; sometimes this occurs on the shoulder area, sometimes in the central area but, in general, it is a purely aesthetic phenomenon that does not affect the performance of the tyre itself.</p>

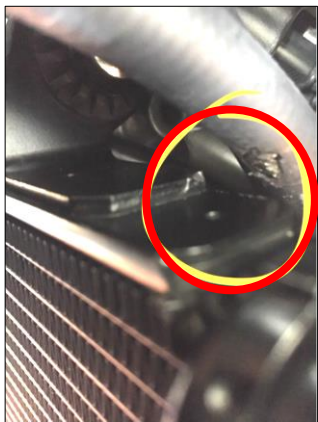
no.	Symptom	Subject	Photo	Notes and Indications - Corrective action
3	<p><u>ONLY</u> Multistrada 950 MY 17-20 Multistrada 1200 MY 15-17 Multistrada 1260 MY18-20 (all model versions)</p> <p>Possible superficial damage to the oil cooler return pipe</p>	Oil cooler pipes

<p>We have received some isolated reports of possible surface damage to the oil cooler return pipe due to rubbing with the top of the coolant radiator, over time. <u>This phenomenon is purely aesthetic and does not affect the correct operation of the system.</u> We inform you that for the models:</p> <p>a) Multistrada 1260: starting from the frame number ZDMAC03AAAKB011354 (on 27/05/2019) the anti-abrasion sheath (1) part no. 4601H701A has been introduced on the oil cooler return pipe, positioned at a distance of 17 cm measured from the upper end of the fitting. (This solution is also applicable to all Multistrada 1200 versions Model Year 2015-2017).</p>

<p>b) Multistrada 950:</p> <ul style="list-style-type: none"> - starting from the frame number ZDMAD00AAKB002259 (on 10/05/2019) the anti-abrasion sheath (1) part no. 4601H701A has been introduced on the oil cooler return pipe, positioned at a distance of 17 cm measured from the upper end of the fitting; - starting from the frame number ZDMAD00AALB005691 (on 12/03/2020) the longer fitting (2) part no. 81510391A has been introduced at the oil return pipe outlet from the cooler.

<p>We ask you to always check the condition of the oil cooler return pipe, and to replace it ONLY if the rubber sheath is damaged and the metallic braided hose can be seen. Follow the assembly notes indicated above according to the reference model. The spare part catalogue has been updated.</p>

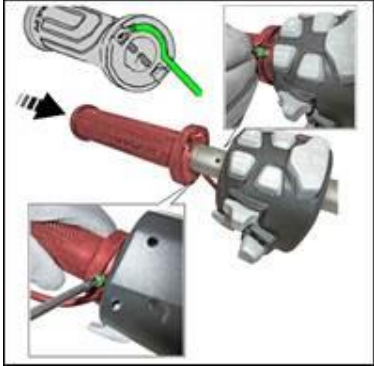
<p>We have received some reports about heated handgrips that have not been installed correctly and so the cable between the handgrip and the switch may be pinched.</p> <p>We kindly ask you to always follow the instructions provided on the DCS under the "accessories catalogue" section or in the model presentation bulletin (SRV-SRB-20-049) and to <u>comply with the correct orientation of the cable and handgrip</u> as shown in the figure.</p>

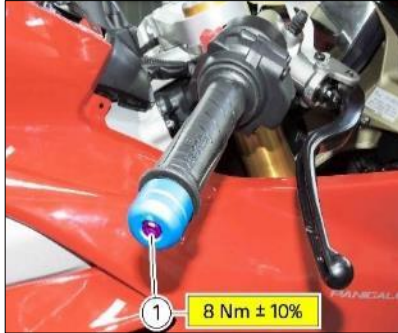
<p>We received some isolated claims about the possible triggering of a longitudinal crack on the handlebar, on balancing weight side. Our laboratory analyses found that said crack is due to an excessive tightening torque applied when installing the balancing weights.</p> <p>When installing balancing weights on the handlebar, please comply with the tightening torque specified for the M6x55 screw to 8 Nm ± 10%, as indicated on the bulletin introducing the model and on the Workshop Manual.</p>

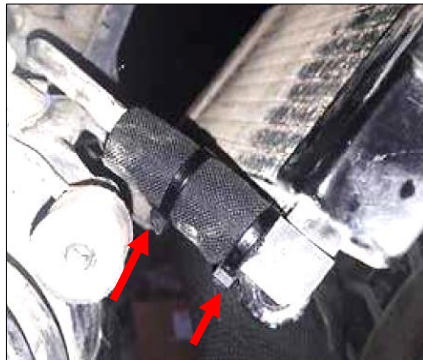
5	<p><u>ONLY</u> Scrambler 1100 PRO (all versions)</p> <p>Irregular operation at idle speed and engine power loss</p>	Vertical cylinder LH spark plug cable	-	<p>As a result of continuous quality tests on the product, we have found a possible irregular operation at idle speed and engine power loss. This phenomenon is due to a settling of the vertical cylinder LH spark plug cable on the coil caused by the contact with the fitting of the oil return pipe from cooler (visible on motorcycle RH side). The MIL light does not come on.</p> <p>We ask you to always check the conditions of vertical cylinder LH spark plug cable and to apply the protective sheath Part no. 4601C581A (cut in half and secured in place with two small self-locking ties) on the fitting of the oil return pipe from cooler to avoid the above-described phenomenon.</p>
