SERVICE BULLETIN

Classification: HA21-002A	Reference: NTB21-071A	Date: October 7, 2021
------------------------------	--------------------------	--------------------------

AUTO HVAC CENTER VENT TEMPERATURE DIFFERENCE GREATER THAN 5°C

APPLIED VEHICLES: 2021 Rogue (T33)
APPLIED DATES: VIN starting with 5N1 – built before March 25, 2021
VIN starting with JN8 – built before April 22, 2021

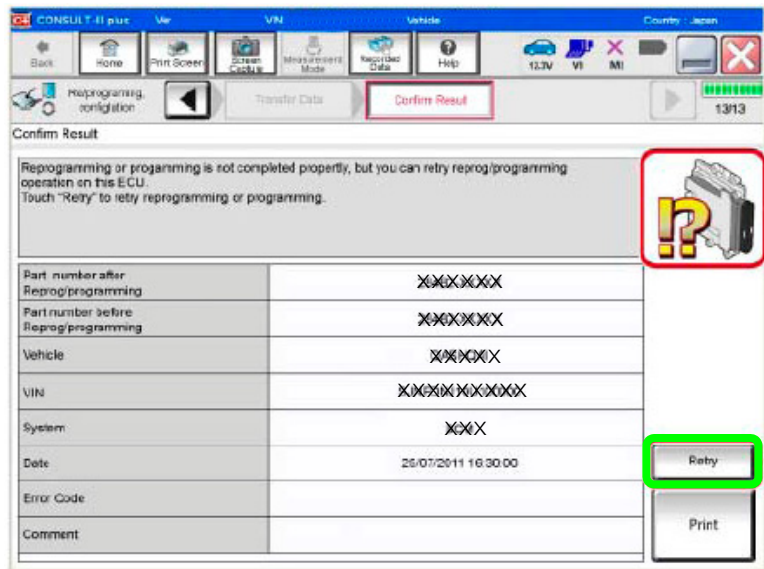
Figure 14

If reprogramming does not complete and the “!?” icon displays, as shown in Figure 14:

- Check battery voltage (12.0 V – 15.5 V).
- Ignition is ON, engine is OFF.
- External Bluetooth® devices are OFF.
- All electrical loads are OFF.
- Select retry and follow the on screen instructions.
- “Retry” may not go through on first attempt and can be selected more than once.

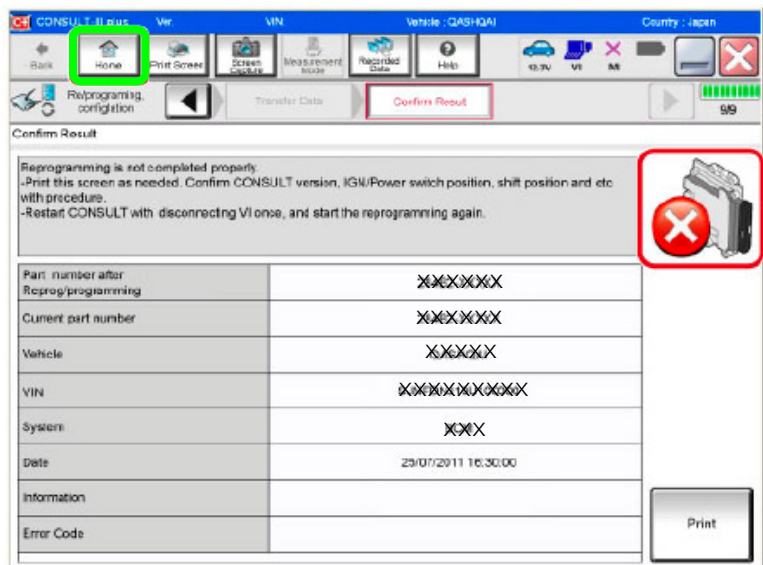
Figure 15

If reprogramming does not complete and the “X” icon displays, as shown in Figure 15:

- Check battery voltage (12.0 V – 15.5 V).
- CONSULT A/C adapter is plugged in.
- Ignition is ON, engine is OFF.
- Transmission is in Park.
- All C-III plus / VI cables are securely connected.
- All C-III plus updates are installed.
- Select Home, and restart the reprogram procedure from the beginning.
