# SERVICE BULLETIN

Classification: EL21-015	Reference: NTB21-093	Date: October 6, 2021
-----------------------------	-------------------------	--------------------------

## WATER INTRUSION INTO REAR COMBINATION LAMP CAN CAUSE MULTIPLE DTCS AND NO-START CONDITION

**APPLIED VEHICLES:** 2016-2021 Titan/Titan XD (A61)

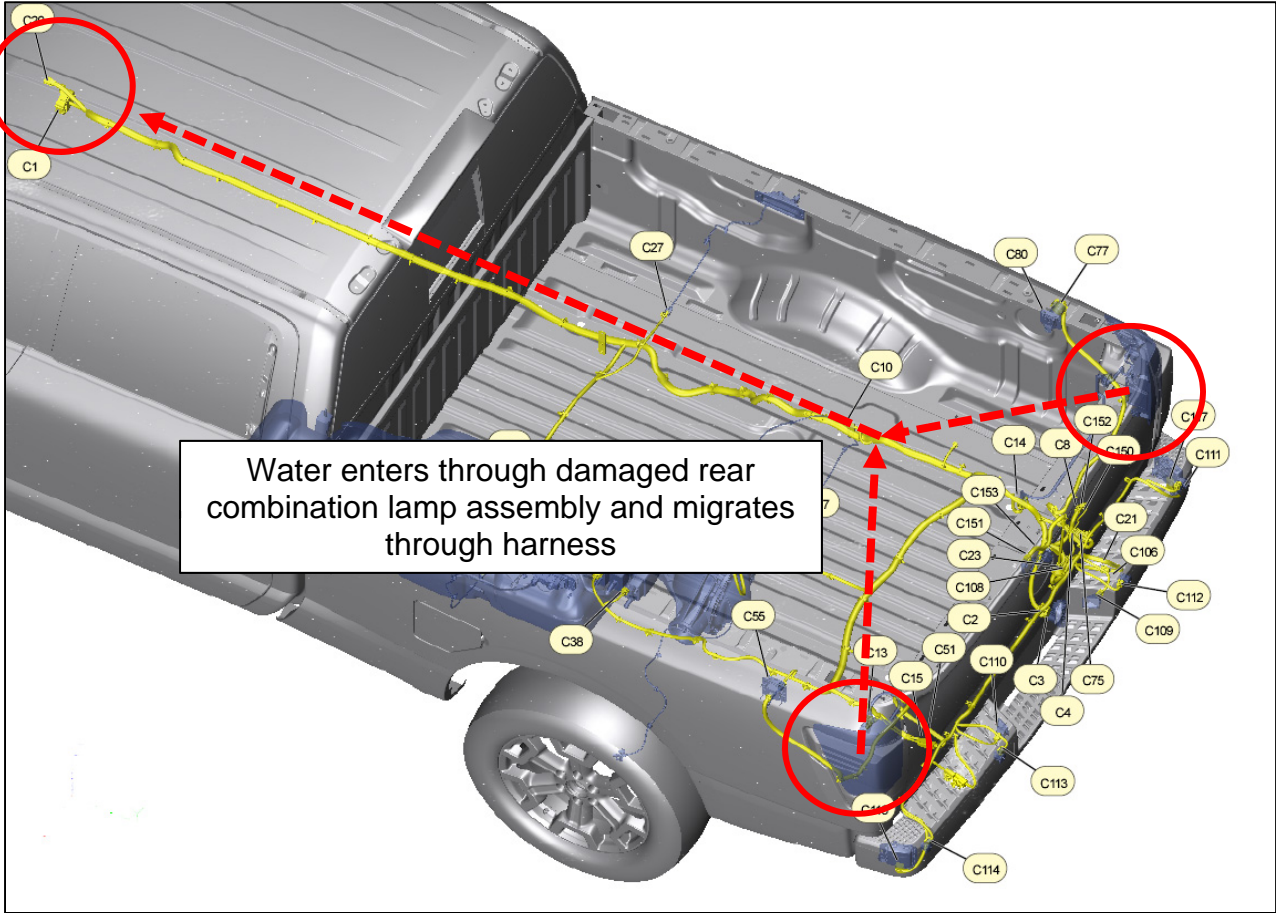
Figure 1

Water intrusion into one or both of the rear combination lamp assemblies can cause multiple DTCs, and possibly cause the vehicle's engine to not start. Water intrusion into one or both rear combination lamp assemblies has been found to migrate through the harness, and can cause harness connector terminals in C1/E41 to corrode (Figure 1 on page 2).

- Repair any damaged rear combination lamp assemblies immediately to avoid potential harness damage.
