Front Roof Console Needs to be Replaced – Observe Specified Procedure (101/21)

Model Line: **Panamera (971)**

Model Year: **As of 2017**

Concerns: **Front roof console needs to be replaced**

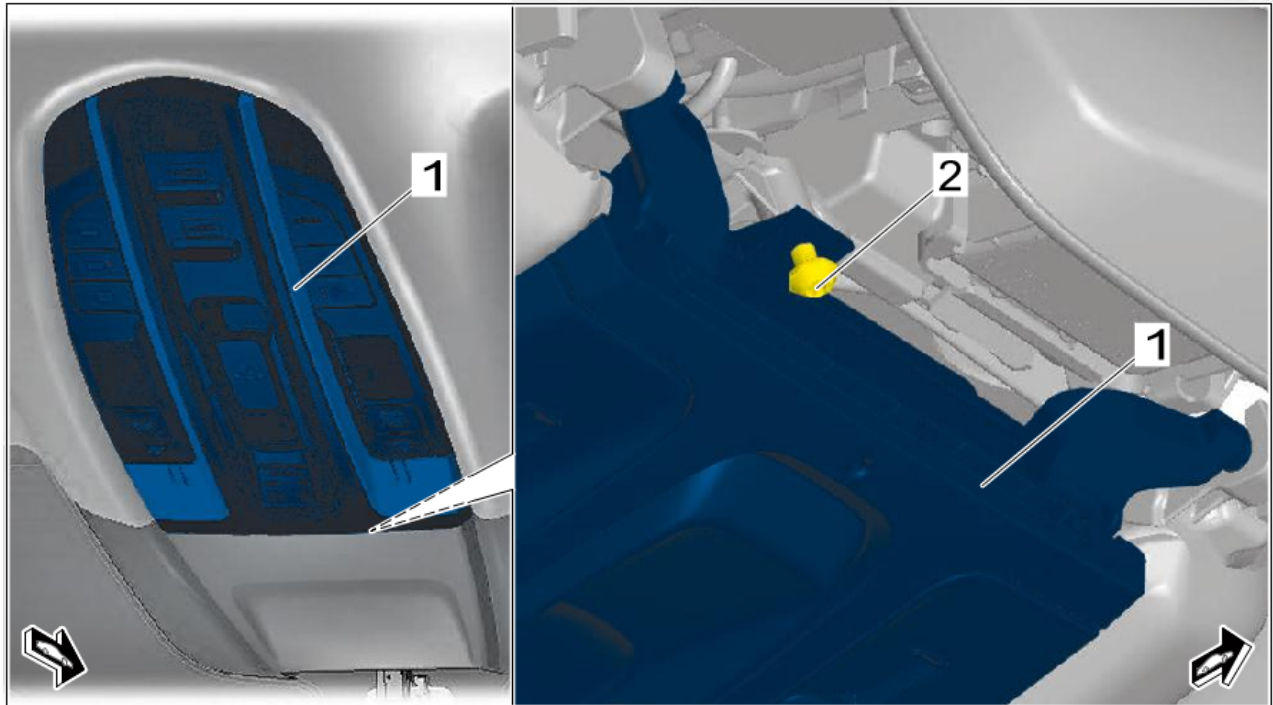
New roof console

The new roof console can be identified by a lug at the front. On vehicles from model year 2021, the roof console is screwed to the roof lining using this lug as well as the retaining clips.

- 1 – **New** roof console
- 2 – **New** threaded connection on roof console

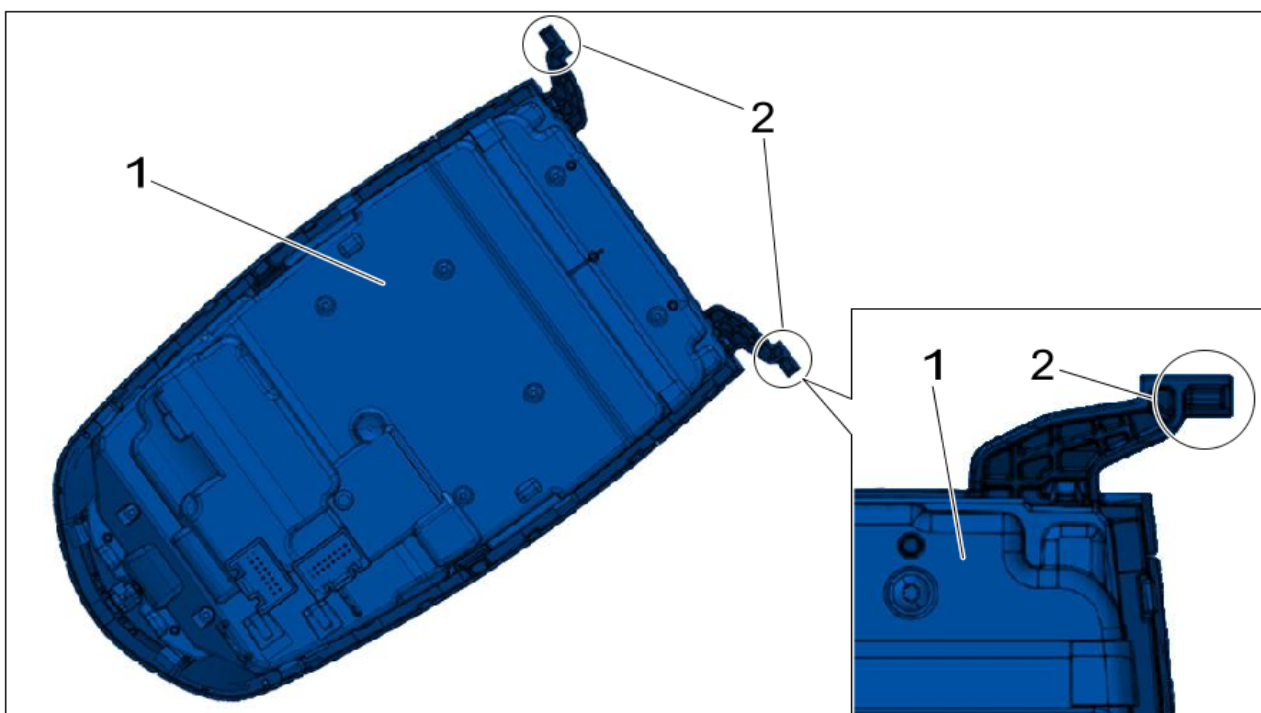
Roof console engagement pins

On old-type roof consoles (without the additional lug), the engagement pins have a smaller diameter than those used on the technically modified roof consoles. To ensure that the old-type roof console is installed without play in a new roof lining, the engagement pins of the roof console require subsequent work.

- 2.1 Cut each of the felt strips to **45 mm/ 1.77 in long and 7.5 mm/ 0.3 in wide**.
- 2.2 Wrap the felt strips you have cut **twice** around the engagement pins ⇒ *Roof console engagement pins -2-* of the **new** roof console ⇒ *Roof console engagement pins -1-*.
- 3 Install **new** roof console.
⇒ *Workshop Manual '708319 Removing and installing front roof console'*

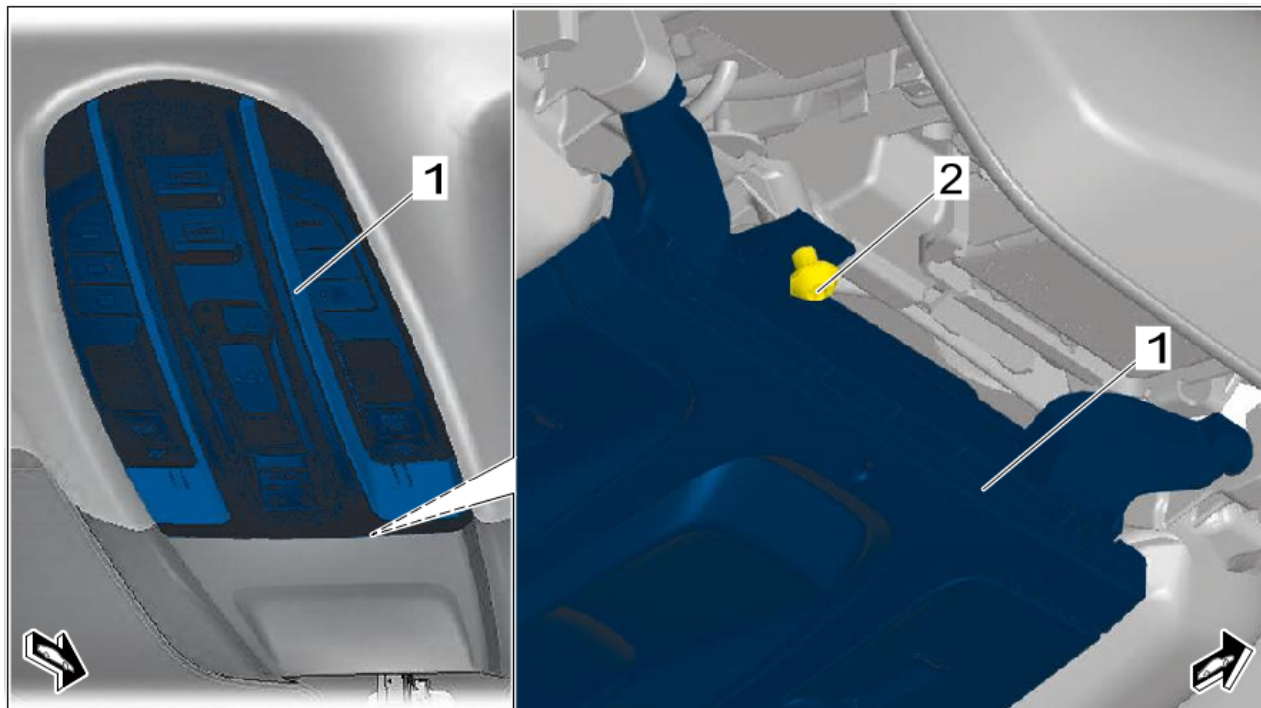
New roof console

An additional threaded connection to the roof lining was used on the new roof console. If you are installing a **new** roof console in a model year 2017 to 2020 vehicle, the threaded connection can be ignored and the roof console can be installed in accordance with instructions in the Workshop Manual.

- 1 – **New** roof console
- 2 – **New** threaded connection on roof console

- 2 Install **new** roof console.
⇒ *Workshop Manual '708319 Removing and installing front roof console'*
