**AMA2 - Replacing Seat Occupancy Detection System for Passenger Seat (USA/Canada)  
(Recall Campaign)**

Revision: This bulletin replaces bulletin Group 6 50/21 AMA2, dated November 4, 2021.

Model Line: **Macan**

Concerns: **Seat occupancy detection system for passenger seat**

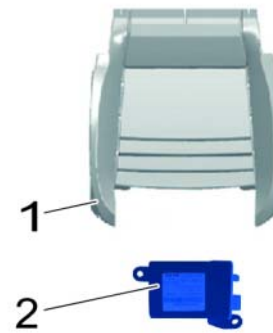
*Contents of occupant classification system repair kit*

- 1 – Padding with affixed sensor mat - **replace**
- 2 – Occupant classification control unit - **reuse**

When replacing the occupant classification components, all coordinated components (padding, sensor mat and control unit) in the repair kit must be replaced.

To avoid delay in the implementation of this measure, the **occupant classification control unit installed in the vehicle is reused** in this particular case.

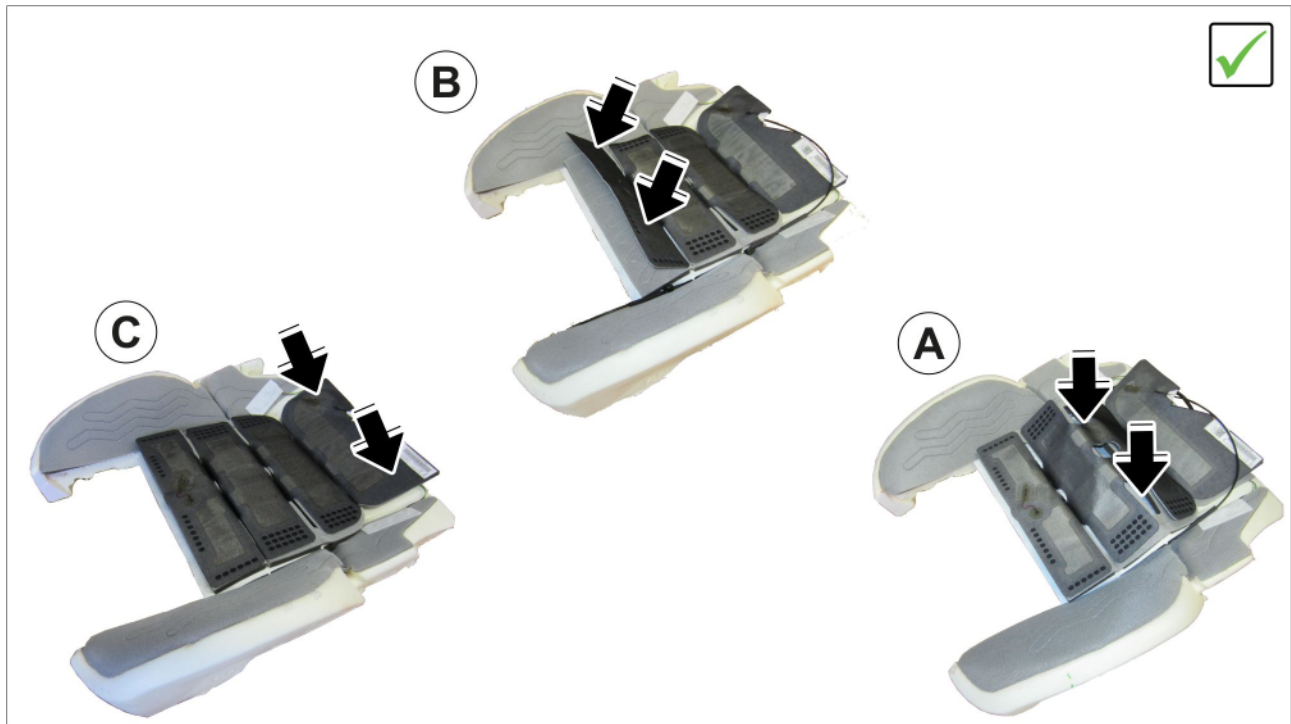
Overview of padding

Between delivery of the padding to its installation in the front seat, the glued sensor mat can partially detach from the foam part over longer periods of time. This does not constitute a material defect and will have no influence on the quality of the sensor mat.

If the sensor mat has come loose as shown in the picture, then the sensor mat must be pressed back in place before installation as shown in pictures A, B, C.  
 Complete adhesive strength is only achieved after attaching or clamping the seat cover.

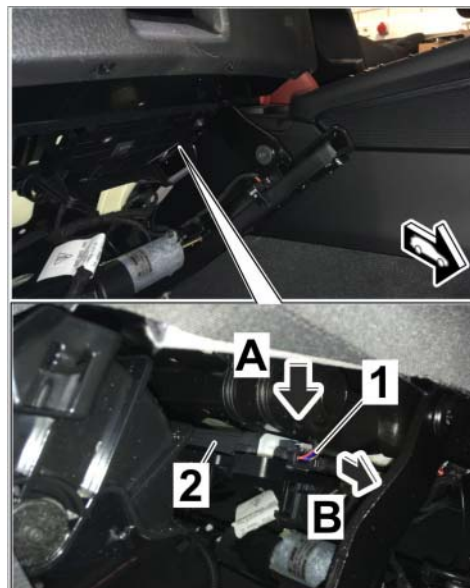
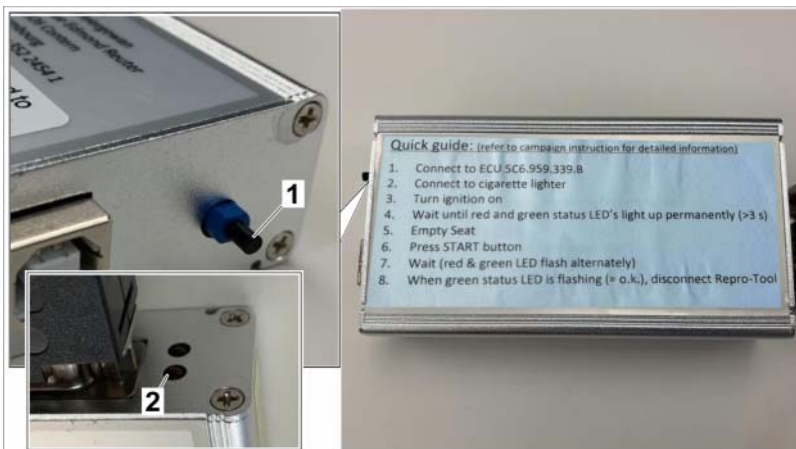
*Re-programming control unit*

- 1 – Start button
- 2 – LED display

- 7.5 Unlock the secondary locking of the plug connection ⇒ *Re-programming control unit -1-* on the occupant detection control unit ⇒ *Re-programming control unit -2-* (⇒ *Re-programming control unit -arrow A-*) and unplug the plug ⇒ *Re-programming control unit -arrow B-*.
- 7.6 Connect the cable set for the programming box to the occupant detection control unit and to the cigarette lighter in the centre console.
- 7.7 Switch on the ignition and reprogram the occupant detection control unit in the vehicle according to the instructions on the programming box.
