Technical product information

Topic	Electronic Parking Brake (EPB) functionality issues
Market area	Russische Föderation (5RU),Australia E04 Bentley rest Asia and Australia (6E04),China 796 VW Import Comp. Ltd (Vico), Beijing (6796),Germany E02 Bentley rest Europe (6E02),Japan E03 Bentley Japan (6E03),Korea, (South) E08 Bentley South Korea (6E08),United Arab Emirates E06 Bentley Middle East and Africa (6E06),United Kingdom E01 Bentley UK (6E01),United States E05 Bentley USA and rest America (6E05)
Brand	Bentley
Transaction No.	2062184/3
Level	EH
Status	Approval
Release date

New Continental GT/GTC and New Flying Spur

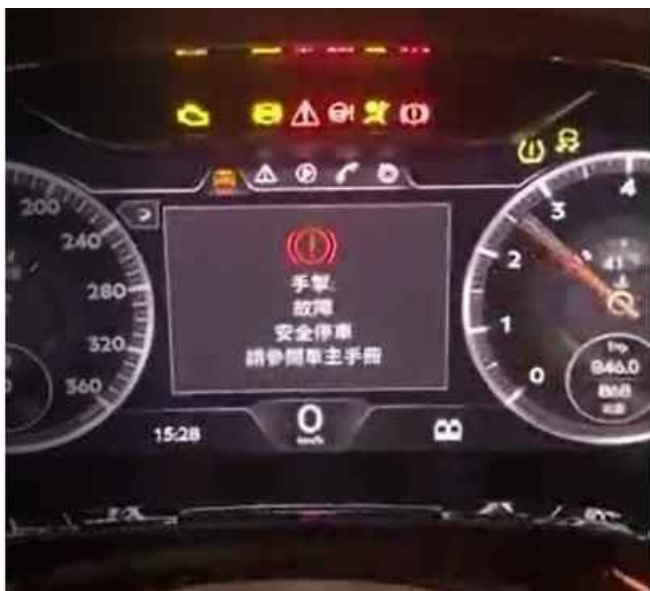
Figure 1

- Electronic Parking Brake (EPB) found not operating to specification
- EPB may not hold the car effectively
- Parking brake components showing signs of wear
- Parking brake warning light may also be evident within the DIP (See example shown in Figure 1)

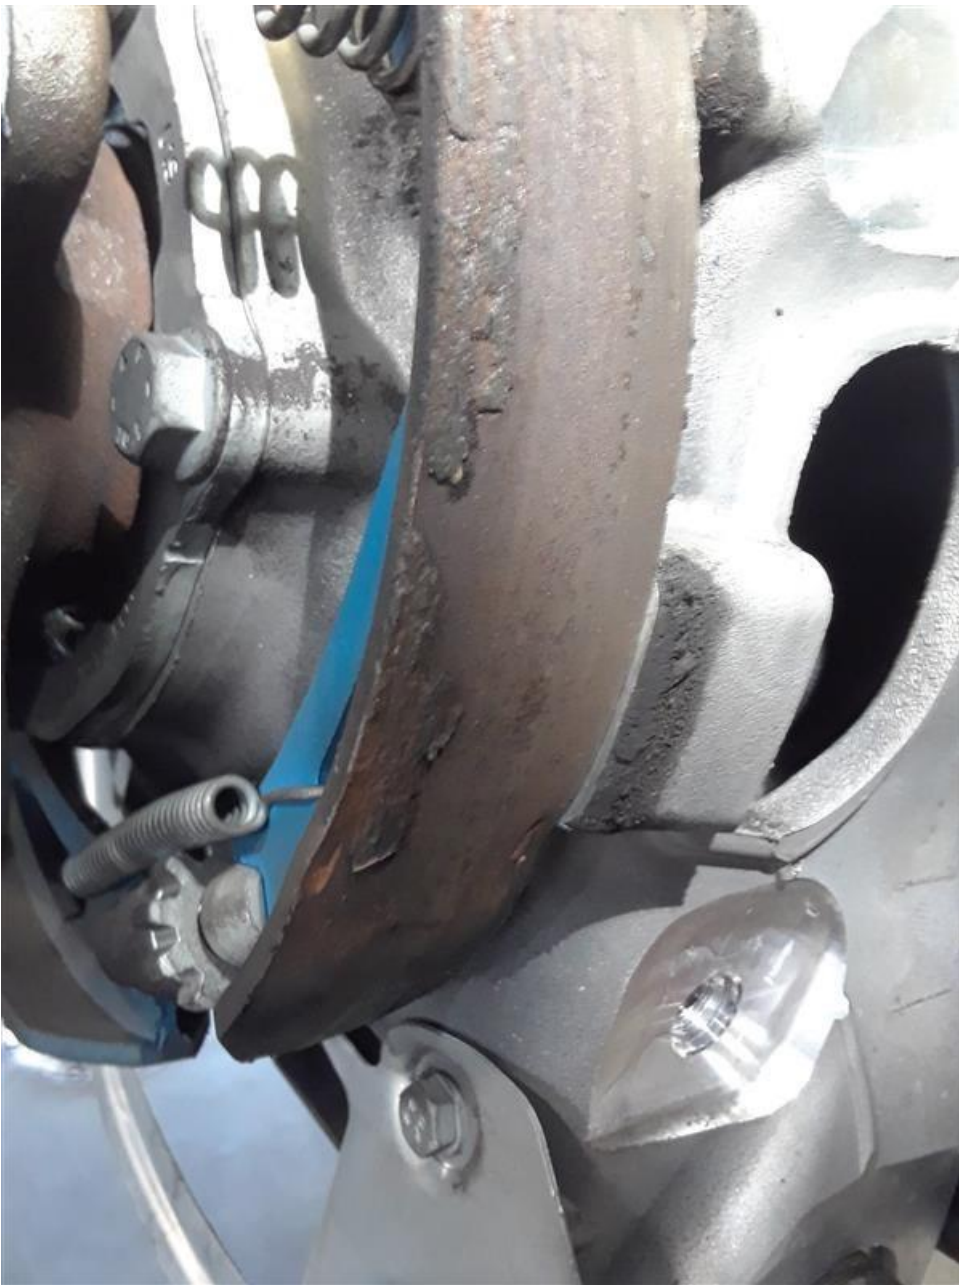
The issues described can be evident due to the car being driven in Transport mode with the EPB applied during the Transit process

- Right and left hand (EPB) Actuators
- Right and left hand rear brake shoes (EPB) – See example shown in Figure 2
