Technical product information

Topic	Knocking noise from the front and/or rear - DTC C1298F1 evident within D4 and/or D5
Market area	Russische Föderation (5RU),Australia E04 Bentley rest Asia and Australia (6E04),China 796 VW Import Comp. Ltd (Vico), Beijing (6796),Germany E02 Bentley rest Europe (6E02),Japan E03 Bentley Japan (6E03),Korea, (South) E08 Bentley South Korea (6E08),United Arab Emirates E06 Bentley Middle East and Africa (6E06),United Kingdom E01 Bentley UK (6E01),United States E05 Bentley USA and rest America (6E05)
Brand	Bentley
Transaction No.	2065085/1
Level	EH
Status	Approval
Release date

New Continental GT/GTC and New Flying Spur

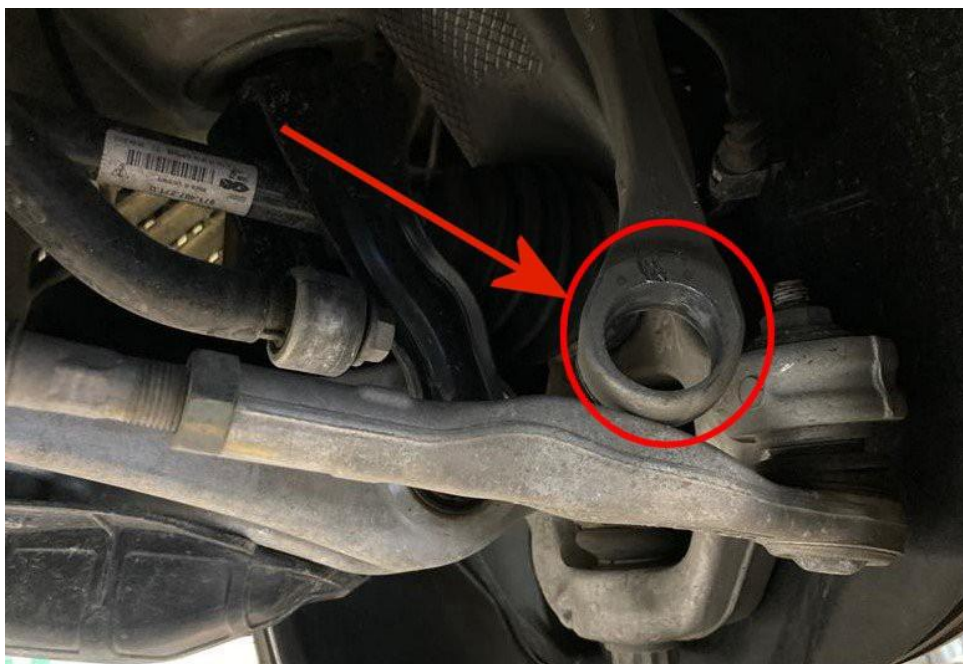
Figure 1

- Knocking noise from the underside of the vehicle (front and/or rear) when driving on uneven road surfaces
- DTCC1298F1 (Suspension stabilization actuator Regulation not possible) evident within diagnostic address D4 and/or D5
- Bentley Dynamic ride fault evident within the DIP

NOTE: The photo shown within this TPI is of the front anti roll bar drop link, please note the issue can also be evident on the rear

1) Check the front and/or rear anti roll bar drop link has not detached (Figure 1) in this scenario DTC (C1298F1: Suspension stabilization actuator Regulation not possible) may be evident within address D4 and/or D5

3) Raise a DISS query ensuring any photos and videos are attached of the issues found NOTE: The operative does not have to wait for a response before replacing parts - Referring to the applicable Rep.Gr - Replace the applicable drop link
