# TECHNICAL TOPICS POWERTRAIN

MY 2017-19 F-Pace, XF, XE, RR Velar with AJ20D4 Engine variant

## Oil ingress in air intake system

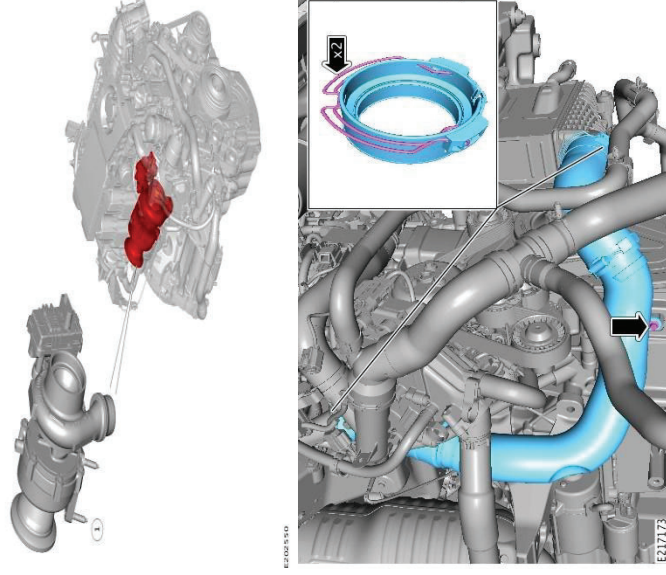
- Oil ingress is found in the intake system, (air-path pipes, manifold and turbocharger)
- Usually after a turbo seal has failed.
- LTS has reported secondary failures after mechanical repairs due to debris/contamination during initial failure, and/or repair.

- Check for leaks and blockages after Turbo replacement.
- Thoroughly inspect and clean air path pipes before starting vehicle in the workshop to make sure all residual oil is removed from air intake system
- Do not replace components due to oil ingress until proven defective.
