SERVICE BULLETIN

Classification: AN21-021	Reference: NTB21-096	Date: October 14, 2021
-----------------------------	-------------------------	---------------------------

SOFTWARE UPDATE FOR INFOTAINMENT ISSUES

APPLIED VEHICLES: 2020 Sentra (B18)
APPLIED GRADES: SV, SR

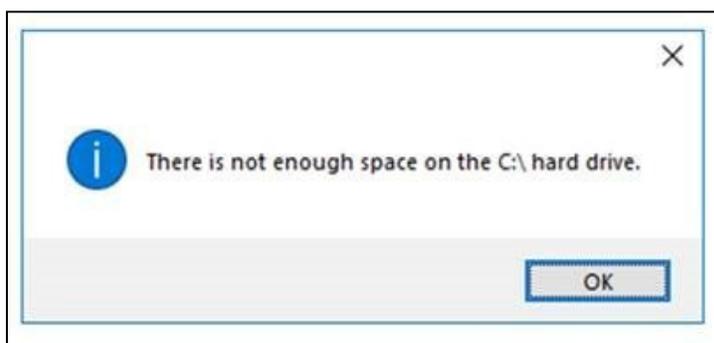
Figure 9

- The update-software is estimated to take **4 hours** to download to the USB drive.
- If, while attempting to download the software to the ASIST Station, you receive the message shown in Figure 9:
 - a. First, attempt to clear space on the ASIST Station hard drive.
 - b. If space on the hard drive cannot be cleared, email Bosch at nissan.dealers@us.bosch.com for additional options.
