# CAMPAIGN BULLETIN

Classification: BT21-021	Reference: NTB21-098	Date: October 25, 2021
-----------------------------	-------------------------	---------------------------

## QUALITY REVIEW FOR RECALL CAMPAIGN R21A7 2021 ROGUE SPORT; BACK DOOR HINGE TORQUE INSPECTION

**CAMPAIGN ID #:** PC848  
**APPLIED VEHICLES:** 2021 Rogue Sport (J11)

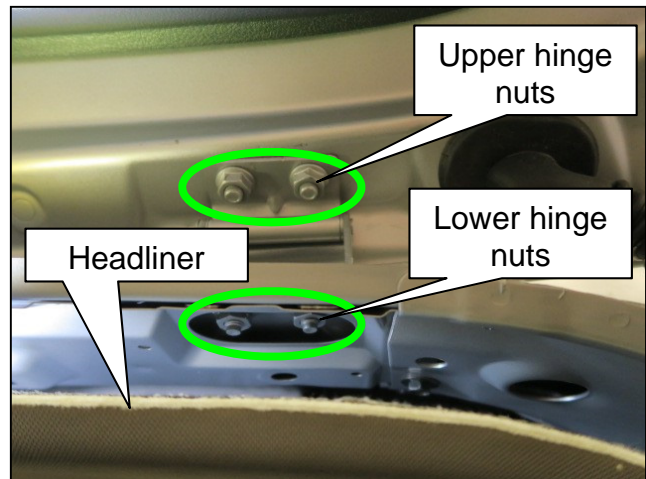
Figure 14

Nissan is conducting this quality review on certain specific model year 2021 Rogue Sport vehicles remedied under campaign ID R21A7 using NTB21-062, to re-torque the nuts on both back door hinge bolts. This service will be performed at no charge to the customer for parts or labor. VINs identified with this campaign ID are being inspected to ensure the R21A7 recall remedy was performed in accordance with Nissan’s quality standards.

15. Loosen the RH side upper and lower back door hinge mounting nuts.

16. Torque all four (4) hinge mounting nuts to 26.0 N•m (2.7 kg-m, **19 ft-lb**).
