QUALITY ACTION

CAMPAIGN BULLETIN

Seat Belt Buckle Bracket Dealer Inventory

Reference: PC849

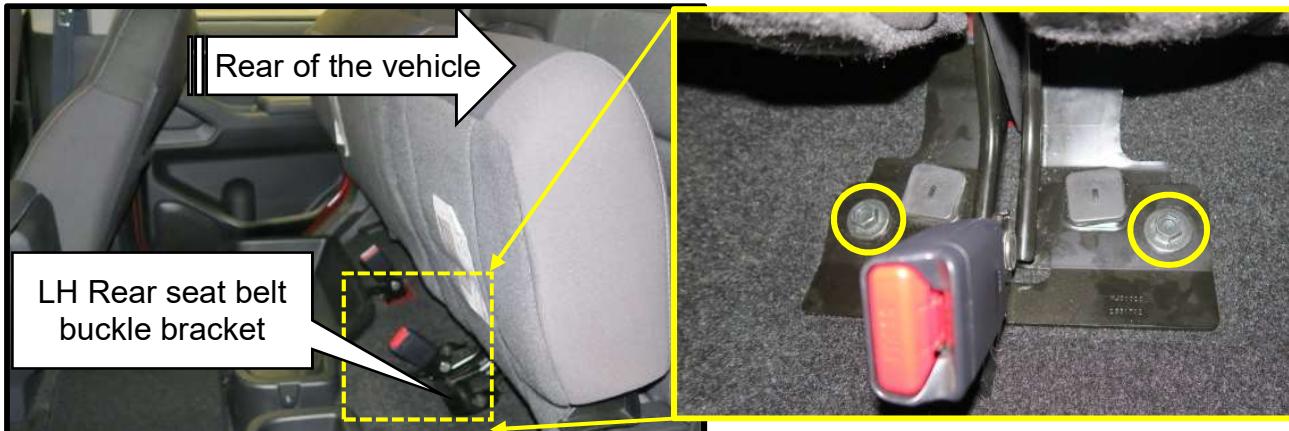
Figure 1

1. Lift both rear seat cushions to the upright position.
 - Open the rear doors
 - Pull the release handles and lift the seat cushions upward until they lock into place
2. Locate the LH rear seat belt buckle bracket bolts. (Figure 1)

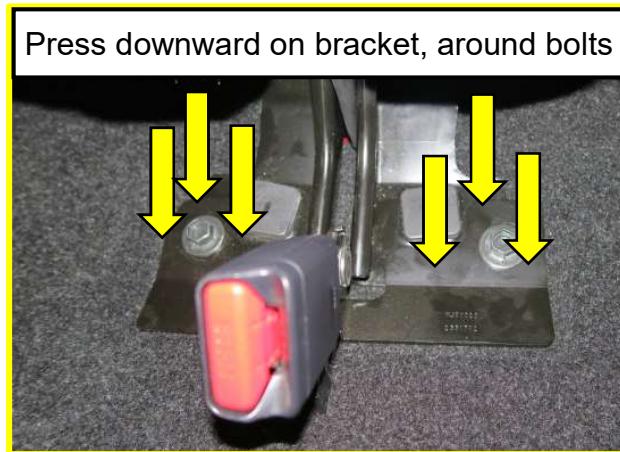
Figure 2

3. Following the three steps below, inspect both bolts that secure the LH rear seat belt buckle bracket to verify they are fully seated.
 - a) Verify the bolts are flush with the seat belt bracket, if either of the bolts are not flush with the bracket, the bolt is not fully seated
 - b) Attempt to turn the bolt washers by hand, if the washer turns, the bolt is not fully seated
 - c) Push downward on the seat belt buckle bracket around each bolt to check for bracket looseness, If the bracket has movement around the bolt, the bolt is not fully seated (Figure 2)
