Revision (1) November 2021

Dealer Service Instructions for:

Customer Satisfaction Notification Y22 Driver Air Bag Emblem

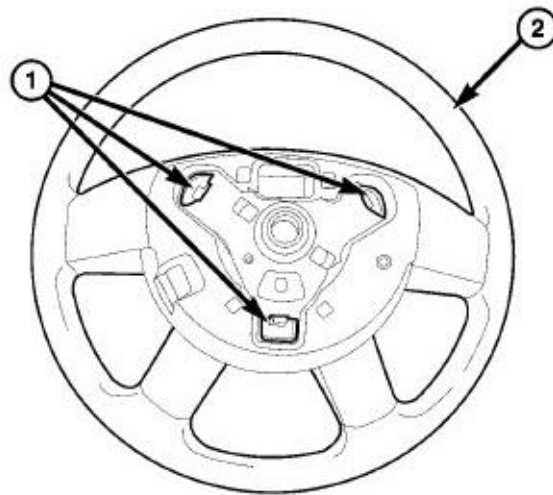
Figure 1 – DAB Retainer Locations

6. There are three DAB retainer access holes (1) on the instrument panel side of the hub of the steering wheel (2), located at the two o'clock, six o'clock and ten o'clock positions. The steering wheel must be rotated to bring each of these access holes up to the twelve o'clock position of the steering column one at a time for removal access (Figure 1).
