Technical Service Bulletin: TSB210235Released Date: 26-Oct-2021Lubricating Oil Pan Gasket Leak and Lubricating Oil Pan Gasket Alignment Procedure

# Lubricating Oil Pan Gasket Leak and Lubricating Oil Pan Gasket Alignment Procedure

• L9 CM2450 L126B

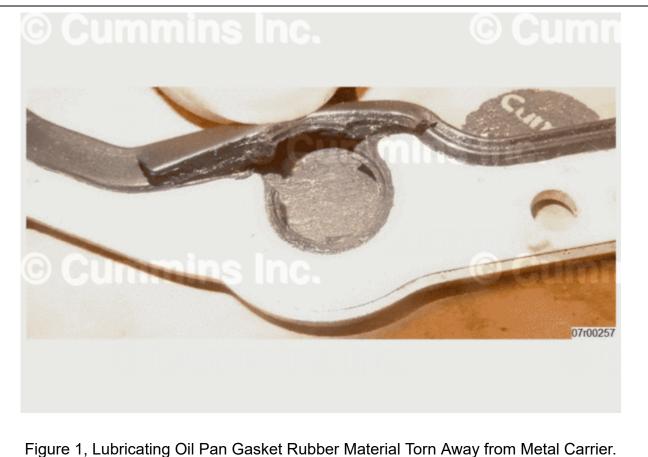
• External lubricating oil leak from lubricating oil pan gasket

• Lubricating oil pan gasket damaged during install caused by misalignment with cylinder block cap screw holes and lubricating oil pan. Damage can occur during assembly at plant or during service repair.

- Verify external lubricating oil leak found coming from the lubricating oil pan gasket. See L9 CM2450 L126B Service Manual, Bulletin 5613077. Refer to Procedure 007-025 in Section 7. (/qs3/pubsys2/xml/en/procedures/583/583-007-025.html)
- Verify Lubricating oil pan gasket rubber material torn away from metal carrier near a cap screw hole as shown in Figure 1 below.
