**SIB 31 01 02**

SERVICE ACTION: Replacement of bolt in the fork stabilizer - 31 001 02 (043)

Bulletin No: 31 001 02 (043)

Subject: Technical Action: Replacement of bolt in the fork stabilizer - F 650 Dakar models only.

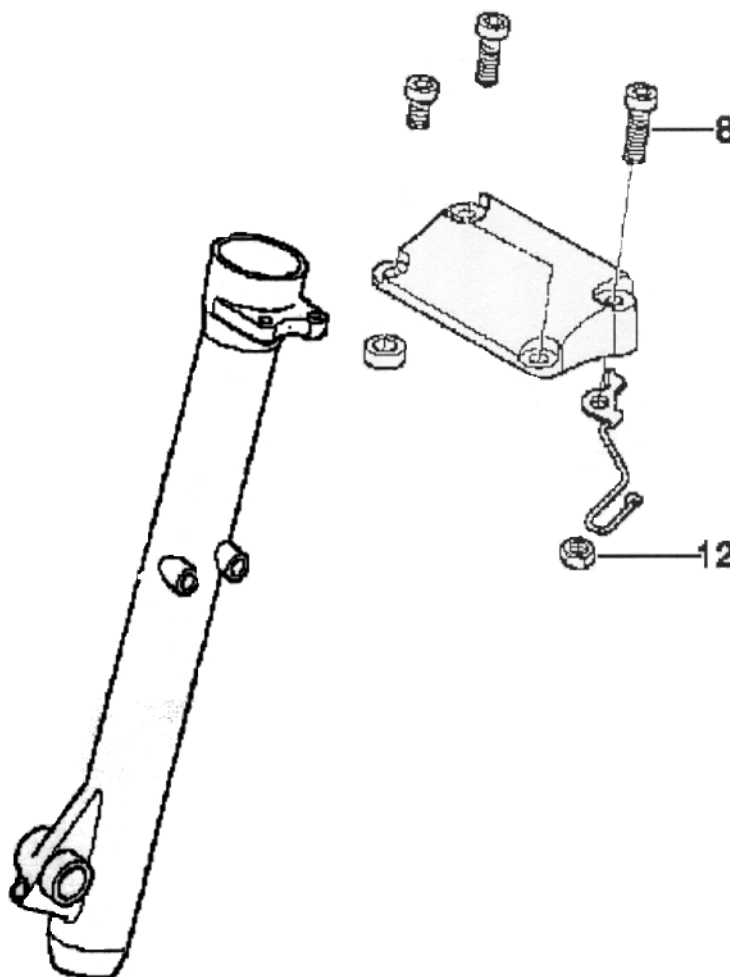
Details: We have been notified by Showa, the manufacturer of the front forks for the F 650 Dakar model, that one of the four mounting bolts, attaching the fork stabilizer to the fork legs is incorrect.

The shank on the incorrect bolt is too long and may not hold properly, even though it was installed to the correct torque.

It is possible that the brake hose holder that is held in place by this bolt may work loose over time.

Service Solution: Remove the mounting bolt (#8 in the illustration below) replacing it with the M8x40 bolt included with this bulletin. Tighten this bolt to 20 Nm.

Install the brake hose holder and securing nut (#12 in the illustration below). Use Loctite 2701 and a tightening torque of 8.5 Nm for this installation.
