**SIB 46 01 14****SERVICE ACTION: Fairing Side Panel Attachment - Bulletin 46 001 14 (023)R**

**Subject:** Fairing Side Panel Attachment

**Model:** S 1000 R (K47)

**Work item: 00 60 295 Reworking both fairing side panels**

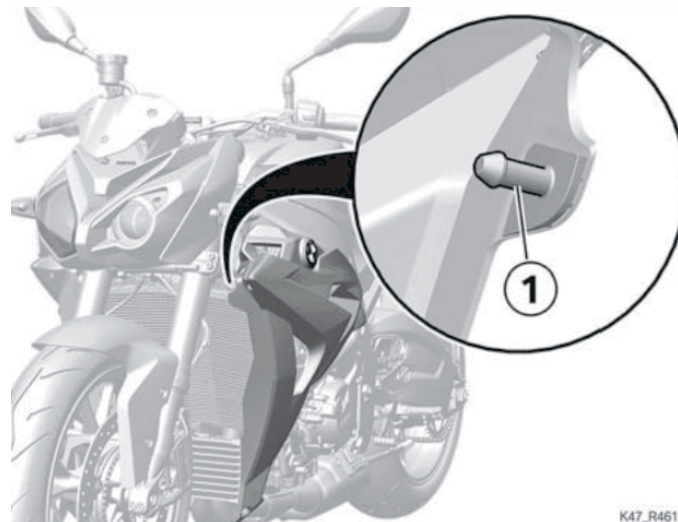
**Details:** BMW Motorrad has ascertained that on account of poor bonding, the front fairing side panels mounting pin can come loose when the vehicle is ridden at high speed. This could allow the slipstream to push the fairing side panels out, away from the frame. Note: The side panels are also held by threaded fasteners, which would keep them attached to the vehicle.

Illustration: Position of the poorly bonded Pin (1)

**Aftersales Solution:** Before handing over a new vehicle to its owner or when vehicles possibly affected by this issue are next brought to the workshop, re-work the mounting points of both fairing side panels (see attached work item 00 60 295 for details).  
Replace the side panel if the pin has already come loose. See current RSD (Repair and Service Data BMW Motorrad) DVD for details.
