Technical Service Bulletin

66 Rear spoiler is inoperative

66 21 79 2065220/1 December 7, 2021.

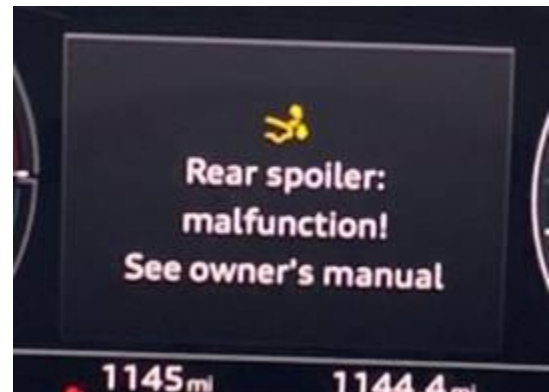
- The message “Rear spoiler: Malfunction!” appears in the driver’s information system (DIS) of the instrument cluster (Figure 1)
- Rear spoiler operation may not be possible.

Figure 1. Message in the driver’s information system.

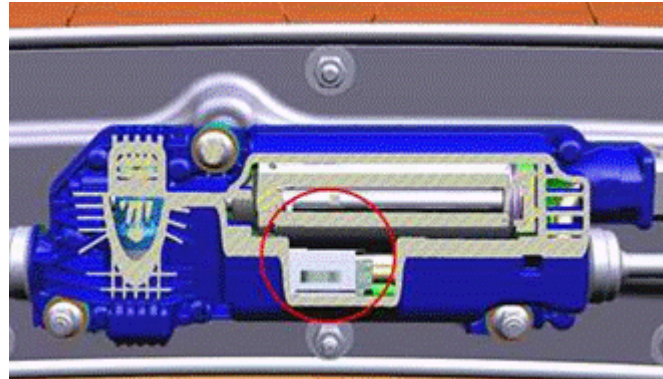
Due to insufficient pressure of the carbon brushes to the motor commutator in the spoiler drive motor a loss of contact may occur and cause intermittent or permanent loss of spoiler operation.

Figure 2 shows the spoiler drive motor area of brush to commutator contact.

Figure 2. Cutaway view of the motor brush to commutator area.

The rear spoiler drive motor has been redesigned. An increase in brush to commutator pressure has been implemented in production.

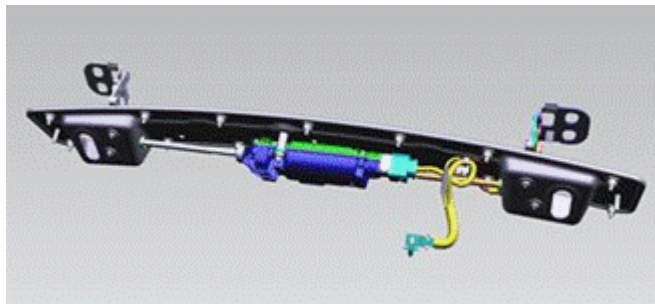
Figure 3. Rear spoiler drive assembly.

1. Should the vehicle exhibit the symptom profile described in this TSB, replace the rear spoiler drive unit. Figure 3 shows the rear spoiler drive assembly.

2. Complete the ODIS test plan and clear DTC(s).
