**SIB 12 01 07****SERVICE ACTION: Replacement of Spark Plugs - Bulletin 12 001 07 (032)R**

## Service Information Bulletin

**Subject:** Replacement of spark plugs

**Model:** F 800 S / ST (K71)

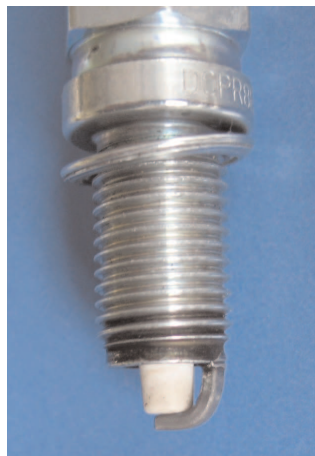
**Details:** The use of a faulty tool in engine assembly has led to isolated cases of damage to the spark plugs.

When the engine is in operation the insulator of the center electrode can break off and slip down until it is in contact with the ground electrode, see photo. This has a detrimental effect on the combustion process.

Insulator broken and slipped down onto ground electrode

**Aftersales Solution:** The spark plugs of each of the motorcycles affected must be replaced.

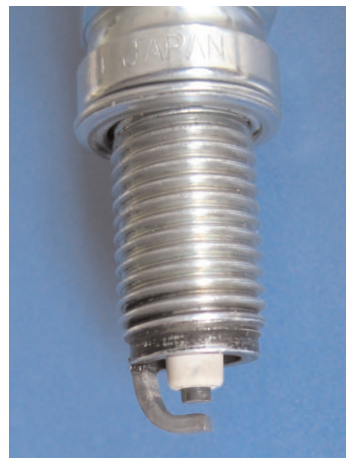
Spark plug in good condition
