No cooling output, fault code 9006 in air conditioning control unit

Topic number	LI83.30-P-049644
Version	7
Design group	83.30 Air conditioning
Date	11-15-2016
Validity	All veh. of model series 164/251
Reason for change	Damage code adjusted
Reason for block

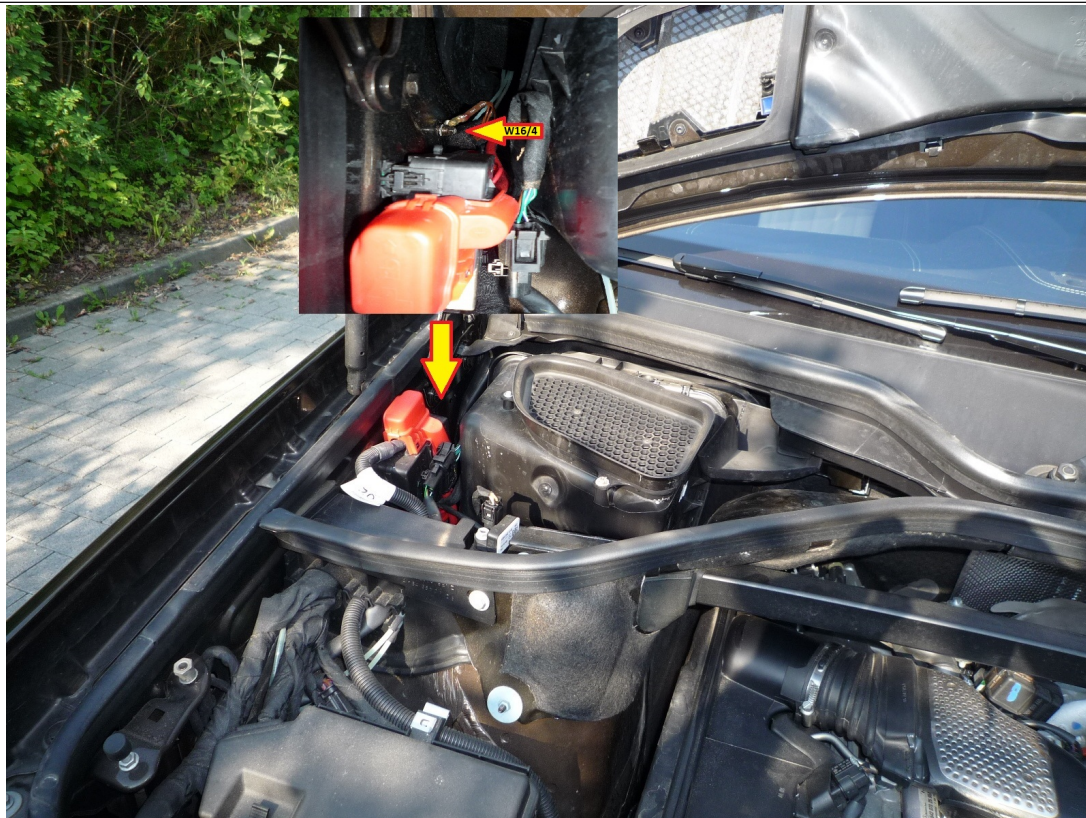
Massepunkt W16-4.jpg:

Attachments	
File	Description
Massepunkt W16-4.jpg	Ground point W16/4

7. From the connection of the regulation valve on the refrigerant compressor one cable with a cable lug is bolted onto the housing of the refrigerant compressor as a ground line; the other cable goes via the connector to the engine wiring harness. An additional ground line with a cross section of 0.75 mm² must be properly routed from the bolt-on point of the ground cable on the housing of the refrigerant compressor to ground point W16/4 in the front right of the engine compartment below the engine hood hinge (see photos in attachment).
