December 16, 2021

Version 4

Warranty Extension: 2016-20 HR-V CVT Premature Belt DeteriorationSupersedes 21-047, Dated August 11, 2021, to revise the information highlighted in **yellow**.**AFFECTED VEHICLES**

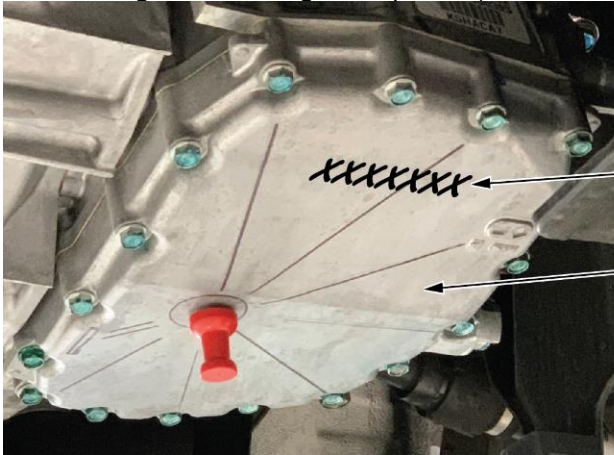
TRANSMISSION OIL PAN

- Provide a clear picture of the magnet sticking on the CVT oil pan at the inspection area (this picture should have been taken during the CVT magnet inspection). Also, write the last seven characters of the VIN on the transmission oil pan.

Write the last seven characters of the VIN.

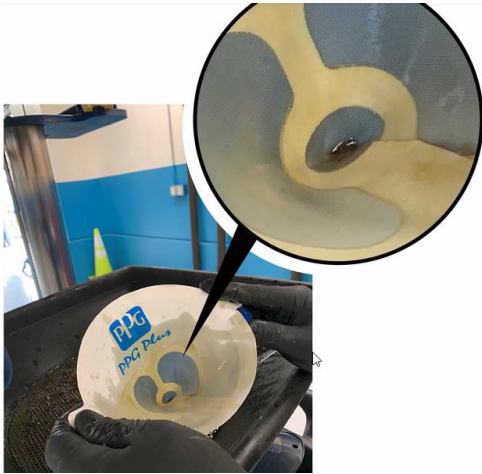
- Drain the CVT fluid through a paint strainer as shown below. Provide a clear picture of the inside of the strainer showing any contamination.

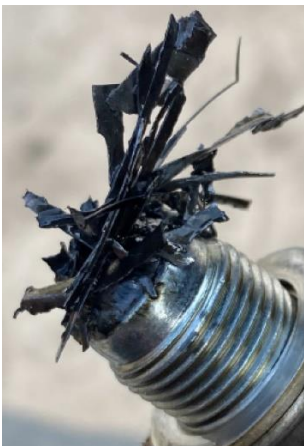
- Provide a clear picture of any contaminants on the end of the oil pan drain plug.
