Service Bulletin

Bulletin No.: 21-NA-247

Subject: Fuel Range Reads Low On Driver Information Center (DIC) Compared to Actual Fuel Range

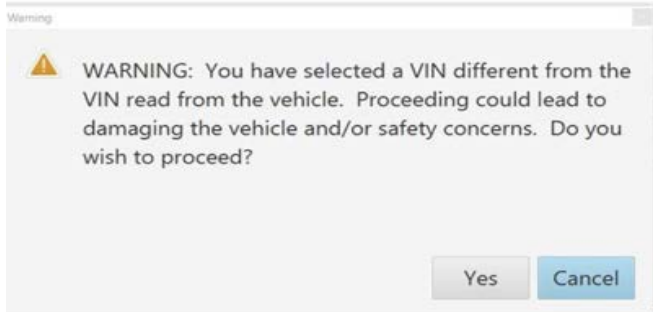
5877000

Important: If the vehicle VIN DOES NOT match, the message below will be shown.

TLC implemented a change that has SPS2 always check that the VIN that TLC is set to matches the VIN read from the VIN master module (ECM for VIP, BCM for GEM). This is to address the potential for an incorrect VIN being set in TLC.
