# Service Bulletin

Bulletin No.: 21-NA-255

**Subject: Engine Misfire, Malfunction Indicator Lamp (MIL) Illuminated - DTC P0300 Set**

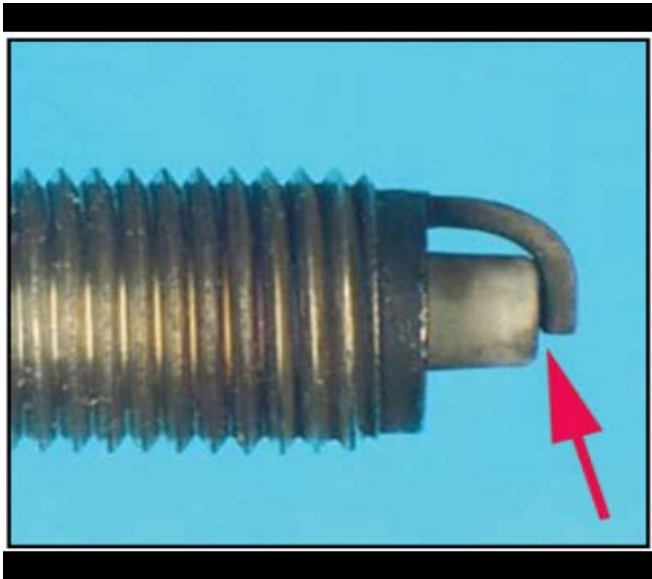
5920461
	This condition may be caused by a broken spark plug insulator.
<b>Correction</b>	If you encounter a vehicle with an engine misfire or engine misfire related DTC, perform the following: <ul style="list-style-type: none"> <li>⇒ Remove the spark plugs from the engine and inspect for a broken center insulator by inverting the spark plug. Once the spark plug has been inverted, you may find the insulator will slide down the center electrode.</li> </ul>

Refer to *Gas Engine Ignition Spark Plug Inspection* and *Gas Engine Ignition Spark Plug Replacement* in SI.
