Service Bulletin

Bulletin No.: 21-NA-268

Subject: Information on Crank No Start or Extended Crank, Malfunction Indicator Lamp (MIL) Illuminated - DTC P0014, P0017, P0365 and/or P0366 Set

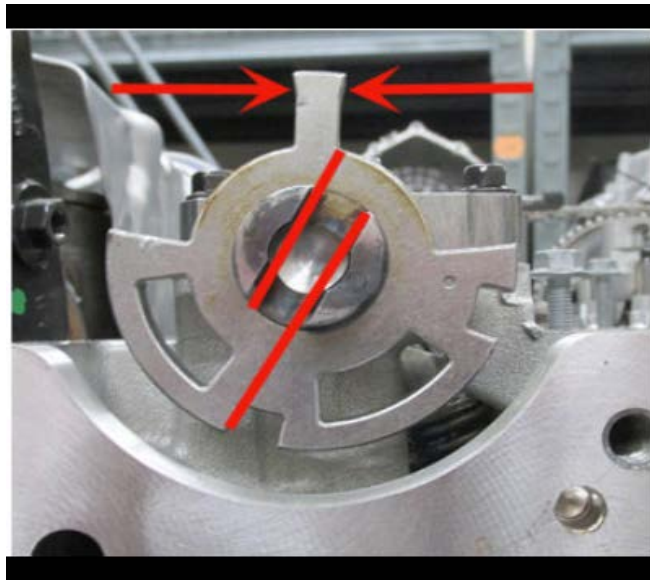
5921666

⇒ Once the exhaust camshaft 2D matrix has been positioned at 12' o'clock, verify the small tang located on the camshaft reluctor ring (Arrows below showing tang on reluctor) is in-line with the 2D matrix marking.

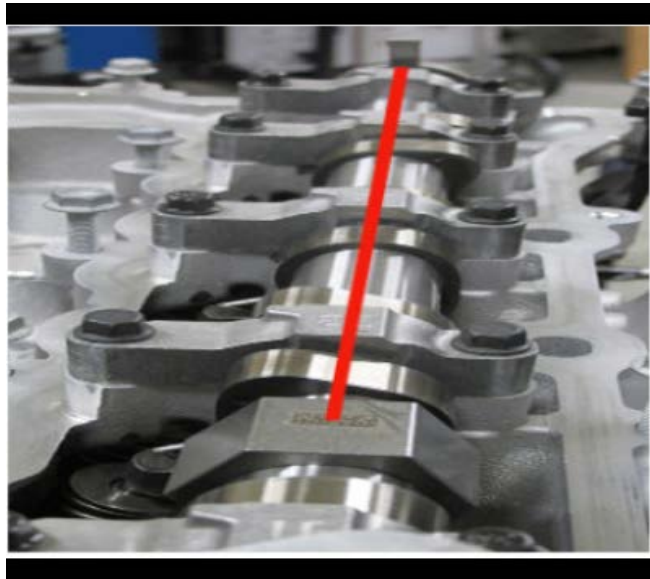
5921670

Also shown are additional reference points used to verify exhaust cam reluctor orientation to camshaft.

Proper relationship between the 2D matrix marking and the small tang on exhaust cam reluctor wheel.

If you find the vacuum pump drive lugs are broken and/or the exhaust camshaft reluctor is out of position, then replacement of the exhaust camshaft and vacuum pump will be required.
