# Service Bulletin

Bulletin No.: 21-NA-271

**Subject:** Information on Malfunction Indicator Lamp (MIL) Illuminated - DTC P026A Set

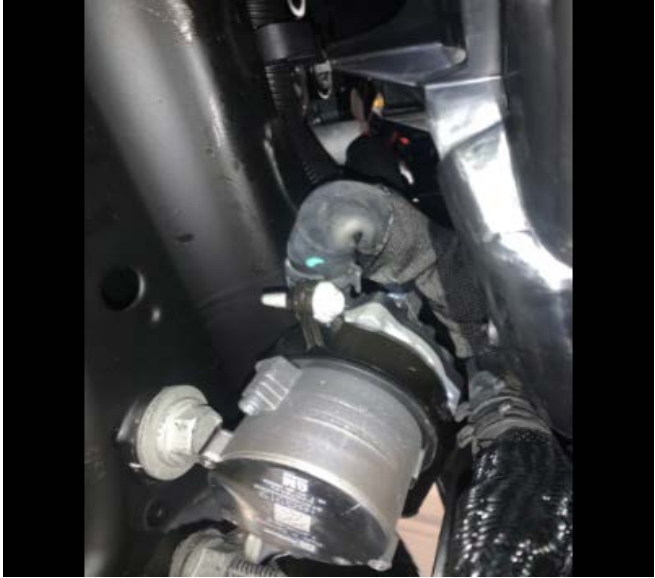
<p style="text-align: right;">5635568</p> <p>If this condition is encountered, loosen the hose clamp and rotate the hose to allow for proper coolant flow.</p>

<b>Involved Region or Country</b>	North America, Uzbekistan, Russia, Middle East, Chile, Columbia, Ecuador, Paraguay, Peru, Uruguay, Japan, S. Korea, Thailand, Australia, New Zealand.
<b>Condition</b>	Some customers may comment that the MIL is illuminated. Some technicians may find DTC P026A set in the Engine Control Module (ECM).
<b>Cause</b>	This may be due to a kinked hose at or near the low temperature auxiliary coolant pump.
