Service Bulletin

Bulletin No.: 21-NA-278

Subject: Diagnostic Strategy for Ticking, Tap or Rattle Noise from Engine with Possible Misfire, Malfunction Indicator Lamp (MIL) Illuminated - DTCs P0300, P0301-P0306 and/or P0016-P0019 Set

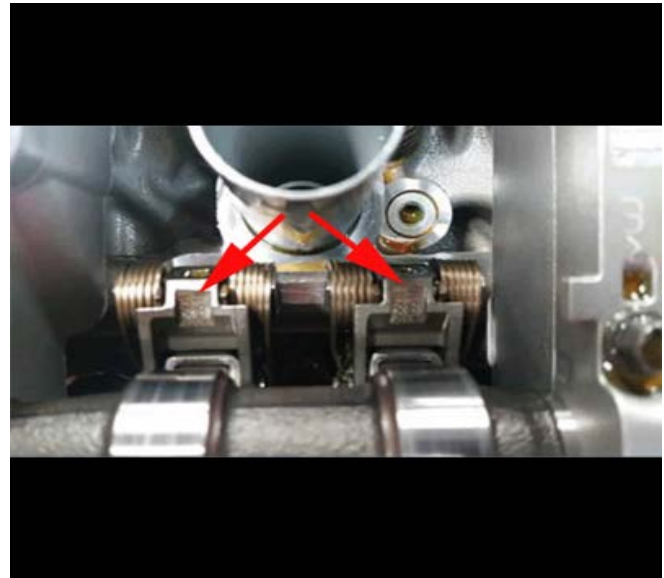
5924232

⇒ Push down on the rocker end at the SHLA to test for soft or spongy feel.

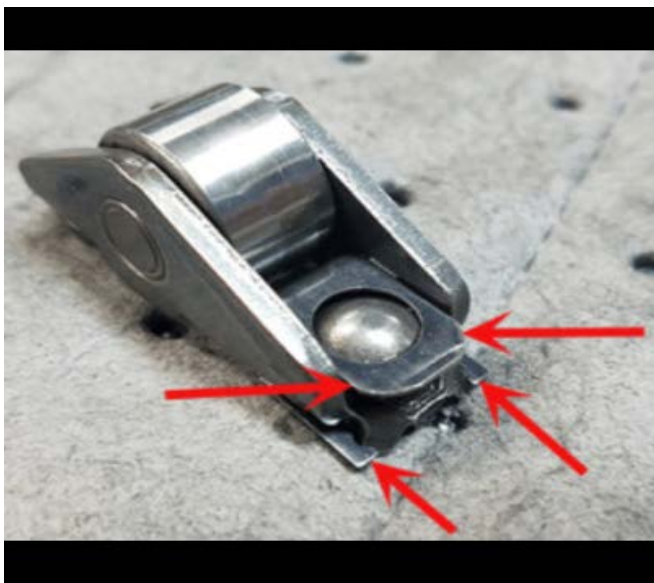
5924230

⇒ Check for any visible damage to non-AFM rocker clips.

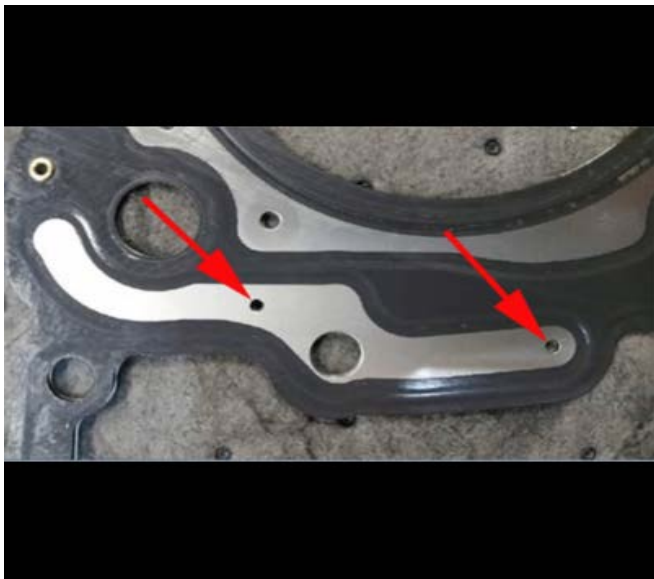
5924231

6. If the replacement SHLAs are still spongy, it will be necessary to remove the affected head and inspect the head gasket for debris in the oil passages as indicated in the graphic above.
 - ⇒ If debris is found, inspect the camshaft caps for wear or discoloration due to lack of oil.
 - ⇒ If wear or discoloration is found, then replace the cylinder head assembly with camshafts.
 - ⇒ If there is no wear or discoloration, clean the oil passages and replace the head gasket.
 - ⇒ Change the oil and filter.
 - ⇒ Reevaluate the noise concern.

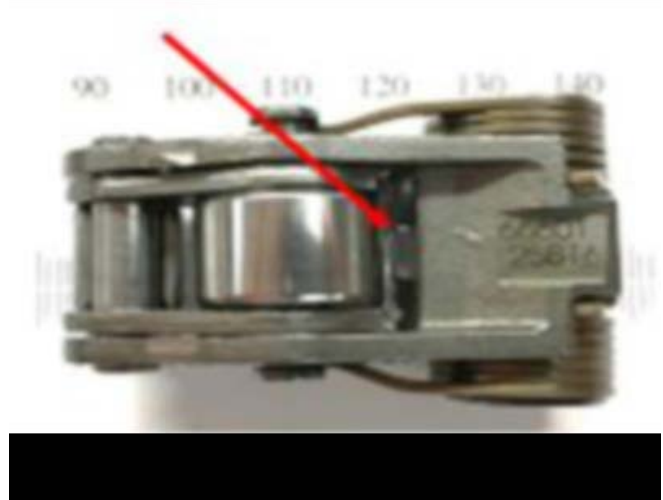
5924237

⇒ Broken or Worn Pin Shelf

⇒ Below are pictures of possible SRFF failures. If any one of the SRFFs are damaged, it will be necessary to replace all four on the affected cylinder.

For any of the above conditions, engine replacement is not necessary. Please perform the repair for the particular issue found.

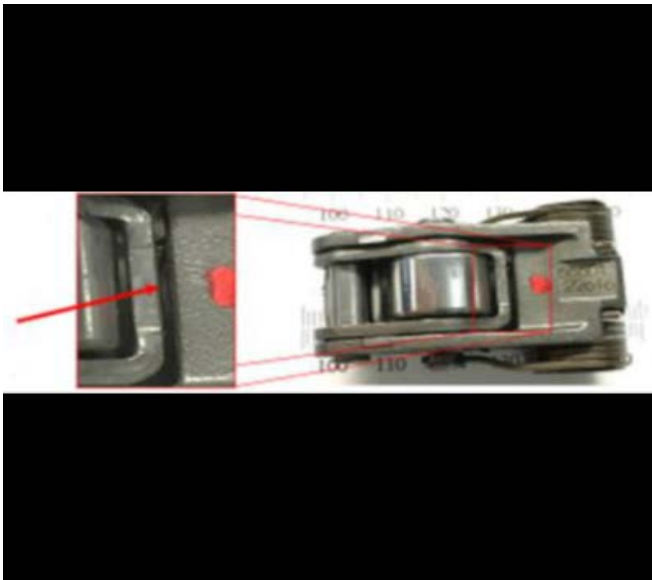
5924233

⇒ Stuck Locking Pin

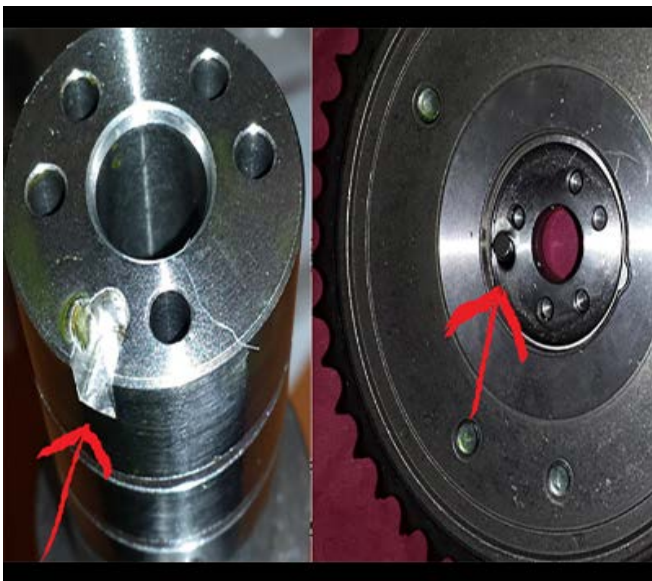
5924235

9. Remove the camshaft actuators on the bank that is misfiring and inspect the end of the camshafts and the pin in the actuators for being bent.
 - ⇒ If any broken parts are found during inspection, replace all damaged parts.

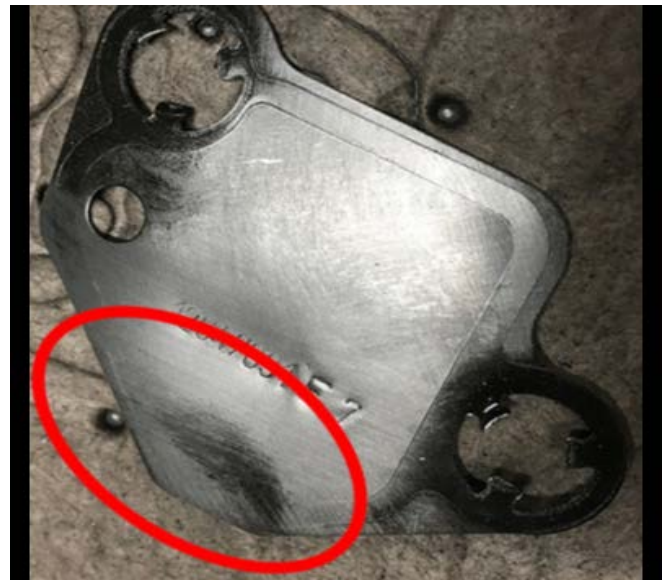
5924234

10. Inspect the left bank timing chain tensioner gasket for not sealing correctly.
 - ⇒ Replace the tensioner and gasket if this condition is found.
11. If noise condition is still present, proceed to step 12.
12. Raise the vehicle while running or with an assistant inside.
 - With chassis ears or a stethoscope, listen to the right and left side of the engine.
 - Once the noise is isolated or if unable to isolate, remove the piston and rod assemblies from the affected bank(s) to inspect for either a loose rod bushing in the rod or a loose wrist pin in the bushing.
 - There should be no metal in the oil for this condition.
 - If this is found, a piston and rod assembly will repair this noise.
