Excessive resistance of door side windows when being raised/lowered, cracking and squeaking noises

Topic number	LI72.00-P-072603
Version	2
Function group	72.00 - General
Date	8/11/21
Validity	MODEL V167 Front doors: From production date September 2019 to April 2021 MODEL V167 Rear doors: From production date September 2019 to May 2021 MODEL C167.3 Rear doors: From production date September 2019 to June 2021 MODEL X167.9 Rear doors: From production date September 2019 to June 2021
Reason for change	Optimized parts available, part numbers updated.

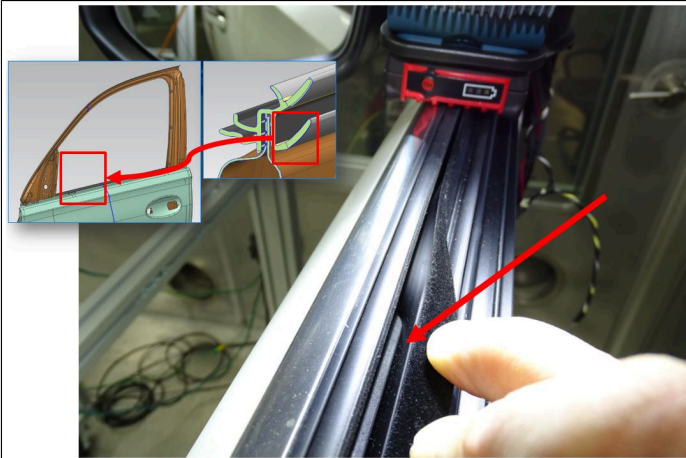
Attachments	
File	Description
Bild 1.JPG

Excessive resistance of door side windows when being raised/lowered, cracking and squeaking noises.

Sealing lip of inner sealing rail, see Picture 1 and Picture 2, pos. 90, folds down while side windows are being lowered (opened).

When the side windows are raised (closed), the sealing lip is pulled back up again.

Replace inner sealing rail.

Then perform normalization of the window lifter system in the relevant door control unit.
