Clattering noise when raising/lowering window using the front door window lifter

Topic number	LI72.10-P-073487
Version	1
Function group	72.10 - Front door
Date	8/17/21
Validity	MODEL 223 up to VIN ending in A023009.
Reason for change

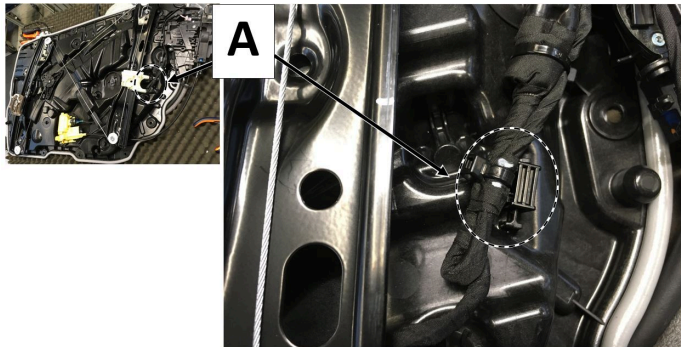
File	Description
Bild 1.JPG

Clattering noise when raising/lowering window using the front door window lifter; occurs when side window is at mid-way point of its travel.

When the side windows are being raised/lowered, the rear window lifter driver may come into contact with the door module wiring harness.

1. Remove door module for front door.
2. In area "A", see Picture1, release the existing cable strap, incl. wiring harness, from the securing strip on the door module. Remove cable strap from wiring harness. Fasten new cable strap (see parts list) to wiring harness and attach to securing strip on door module. Pay particular attention to the position of the wiring harness on securing strip, see Picture 1. After fastening wiring harness, cut off excess length of cable strap.
3. In area "B", fasten wiring harness to tab on door module with a cable tie, see Picture 2. After fastening wiring harness, cut off excess length of cable strap.
4. Install door module.
