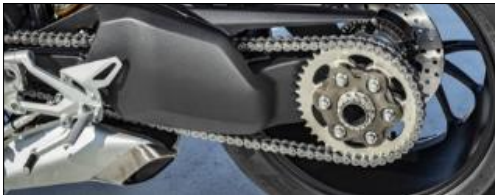
| no. | Symptom | Subject | Photo | Notes and Indications - Corrective action |
|---|--|---|--|---|
| 5 | <p><u>ONLY</u> models equipped with DQS (Ducati Quick Shift)</p> <p>Precautions for a correct use of the DQS (Ducati Quick Shift)</p> | DQS (Ducati Quick Shift) | | <p>We have received reports of some complaints about rough shifting with DQS, particularly at low rpm. In other words, rough shifting with uncomfortable torque cuts.</p> <p>We have checked that very often the cause is related to an incorrect chain tensioning, especially after the first settling of the chain which takes place at around 200/300 Km (new motorcycle or chain). We therefore invite you to always check the correct tensioning of the final drive chain before making further analysis.</p> |

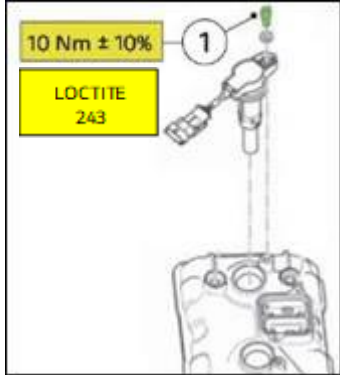
| no. | Symptom | Subject | Photo | Notes and Indications - Corrective action |
|---|---|---|--|---|
| 10 | <p><u>ONLY</u> <u>Panigale V4</u> <u>StreetFighter V4</u> <u>(all model versions)</u></p> <p>Possible engine power delivery discontinuity</p> | Engine power delivery | - | <p>We have received some isolated reports about a possible engine power delivery discontinuity.</p> <p>Before making further analyses, we would like to ask you to check coil fastening and, in particular, to <u>apply LOCTITE 243</u> along the threading of fastening screws and tighten them to 10 Nm ± 10%.</p> |

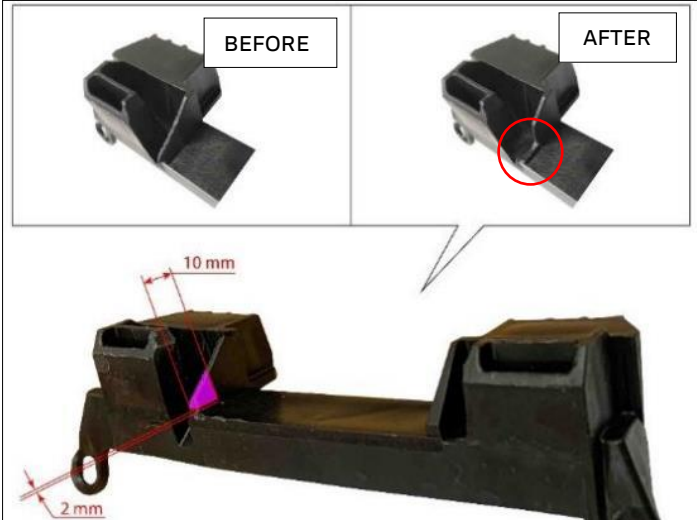
| no. | Symptom | Subject | Photo | Notes and Indications - Corrective action |
|---|--|---|---|--|
| 1 | <p><u>ONLY</u> Multistrada 1260 (all model versions)</p> <p>Possible wrong coupling between rider's seat lower riser and RH side body panel in seat "high configuration"</p> | Rider seat | | <p>When mounting the rider seat in "high configuration", an excessive gap can be seen between the lower trim and the RH side panel. This is due to interference between the central riser and its support. To avoid such interference and therefore improve the coupling between the rider seat and the side panel, it is necessary to:</p> <ol style="list-style-type: none"> 1) Remove the center riser from the seat; 2) Working on the RH side support, remove the excess material with a cutter, as shown in the figure. 3) Reinstall the center riser to the seat. |

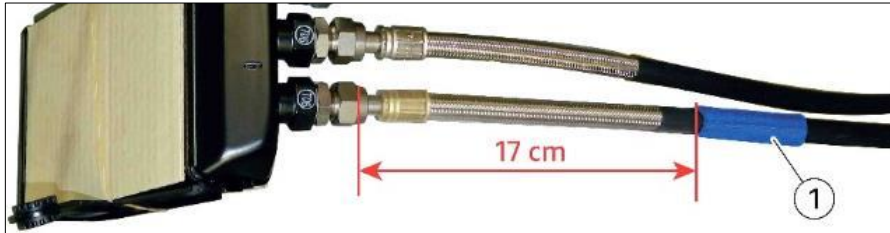
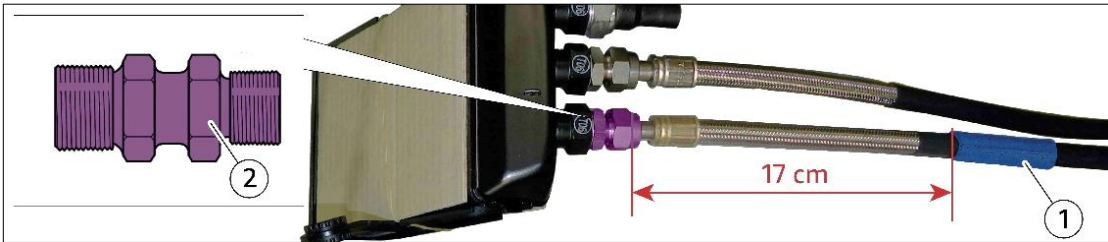
| no. | Symptom | Subject | Photo | Notes and Indications - Corrective action |
|---|--|---|---|---|
| 3 | <p><u>ONLY</u> Multistrada 950 MY 17-20 Multistrada 1200 MY 15-17 Multistrada 1260 MY18-20 (all model versions)</p> <p>Possible superficial damage to the oil cooler return pipe</p> | Oil cooler pipes | | <p>We have received some isolated reports of possible surface damage to the oil cooler return pipe due to rubbing with the top of the coolant radiator, over time. <u>This phenomenon is purely aesthetic and does not affect the correct operation of the system.</u> We inform you that for the models:</p> <p>a) Multistrada 1260: starting from the frame number ZDMAC03AAAKB011354 (on 27/05/2019) the anti-abrasion sheath (1) part no. 4601H701A has been introduced on the oil cooler return pipe, positioned at a distance of 17 cm measured from the upper end of the fitting. (This solution is also applicable to all Multistrada 1200 versions Model Year 2015-2017).</p> <p>b) Multistrada 950:</p> <ul style="list-style-type: none"> - starting from the frame number ZDMAD00AAKB002259 (on 10/05/2019) the anti-abrasion sheath (1) part no. 4601H701A has been introduced on the oil cooler return pipe, positioned at a distance of 17 cm measured from the upper end of the fitting; - starting from the frame number ZDMAD00AALB005691 (on 12/03/2020) the longer fitting (2) part no. 81510391A has been introduced at the oil return pipe outlet from the cooler. <p>We ask you to always check the condition of the oil cooler return pipe, and to replace it ONLY if the rubber sheath is damaged and the metallic braided hose can be seen. Follow the assembly notes indicated above according to the reference model. The spare part catalogue has been updated.</p> |

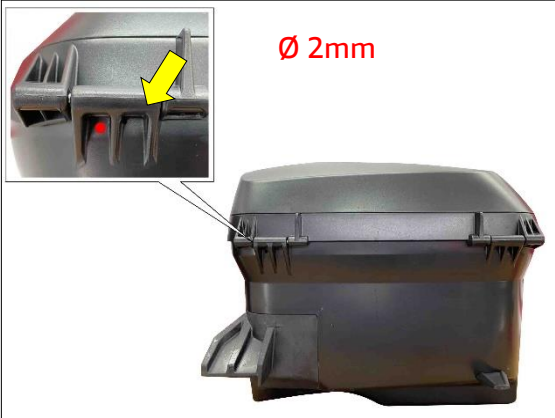
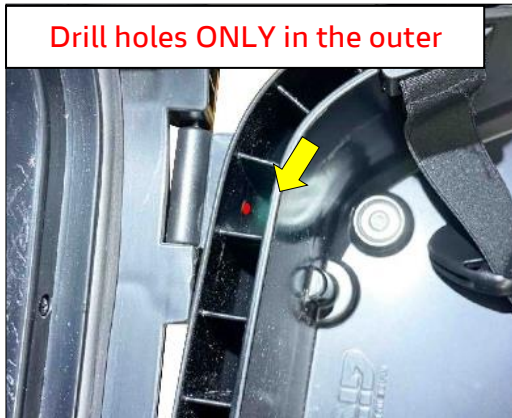
| no. | Symptom | Subject | Photo | Notes and Indications - Corrective action |
|---|---|--|--|--|
| 10 | <p>ONLY Multistrada V4 (all model versions)</p> <p>Difficulties in opening the side panniers part no. 96781551AA</p> | <p>Side panniers part no. 96781551AA</p> | | <p>We have received a few isolated reports of possible difficulties in opening the side panniers due to the “vacuum” effect that occurs when travelling with significant changes in altitude.</p> <p>To avoid this phenomenon, it is necessary to drill a venting hole with a maximum diameter of Ø 2 mm at the bottom of the bag, between the ribs near the rear hinge as shown in the figure.</p> <p><u>DO NOT drill through the second internal wall of the bag.</u></p> <p>This modification has also been implemented by the supplier and does not affect the water tightness.</p> <div style="display: flex; justify-content: space-around;"> <div data-bbox="1055 616 1608 1035"> <p style="color: red; font-weight: bold;">Ø 2mm</p> </div> <div data-bbox="1626 616 2136 1035"> <p style="color: red; font-weight: bold;">Drill holes ONLY in the outer</p> </div> </div> |

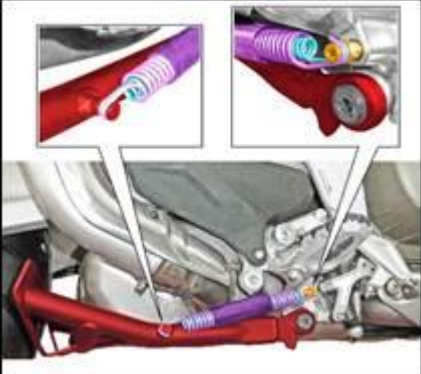
| no. | Symptom | Subject | Photo | Notes and Indications - Corrective action |
|---|---|--|--|--|
| 11 | <p>ONLY Multistrada V4 (all model versions)</p> <p>Possible interference between external central stand return spring and footpeg holder plate</p> | <p>Central stand</p> | | <p>We have received a few isolated reports of possible interference between the external central stand return spring and the footpeg holder plate when the central stand is closed.</p> <p>We kindly ask you to check that the two side stand return springs are correctly installed and aimed as shown in the figure.</p> |

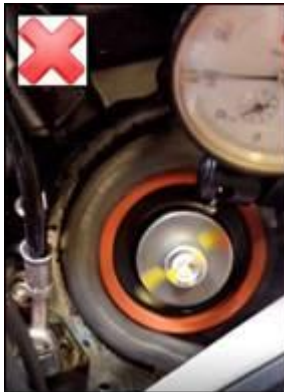
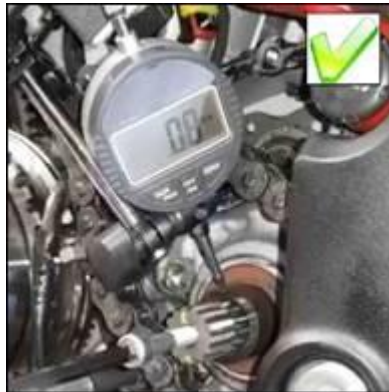
| no. | Symptom | Subject | Photo | Notes and Indications - Corrective action |
|---|---|---|---|--|
| 19 | <p>ONLY <u>Multistrada V4</u> <u>(all model versions)</u></p> <p>Possible oscillation of the final drive chain (non-uniform sliding)</p> | Gearbox secondary shaft | - | <p>We have received some isolated reports about a possible oscillation of the final drive chain even if the chain is correctly tensioned. In these cases the customer may complain an uneven sliding of the chain at constant speed.</p> <p>In these cases, you are asked to check for a possible deformation of the gearbox secondary shaft by removing both the chain and the sprocket and taking the measurement with a dial gauge directly on spacer Part no. 713P0011C, as shown in the figure (the measurement should NOT be taken on the sprocket since an uneven wear of the rubber material may occur during the first few kilometers): by slowly rotating the shaft, the value taken with the dial gauge must be at most 0.1 mm.</p> <div style="display: flex; justify-content: space-around;"> </div> <p>a) If the measurement shows values below 0.1 mm, replace the sprocket only. a) If the measurement shows a value greater than 0.1mm, fill out a Youtech service request.</p> |

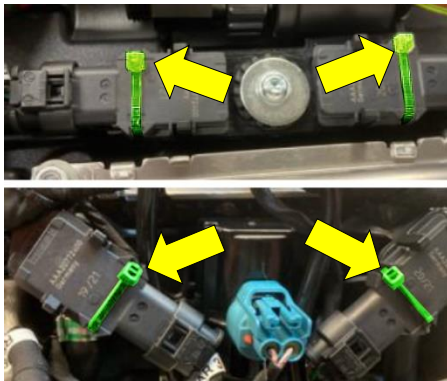
| no. | Symptom | Subject | Photo | Notes and Indications - Corrective action |
|---|---|--|---|---|
| 35 | <p>ONLY <u>Multistrada V4</u> <u>(all model versions)</u></p> <p>Possible erratic idling rpm and hard starting</p> | Engine | | <p>We have received a few isolated reports of erratic engine operation at idle, hard starting, the possibility of the MIL warning light on the instrument panel coming on and/or memorized MAP sensor errors or P061B Torque Monitoring error.</p> <p>Our analysis has shown that this phenomenon could be due to the MAP sensors not fitting perfectly in their seats; we therefore ask you to check the correct installation of the MAP sensors if the symptoms described above should occur, and to fix them properly using self-locking ties positioned as shown in the figure.</p> <p>Create a Youtech for any cases found in your dealership. Attach PDF copy of the DDS Fault Report (with freeze frame parameters) and photos of the MAP sensor(s) as discovered during inspection and after with self-locking ties.</p> |

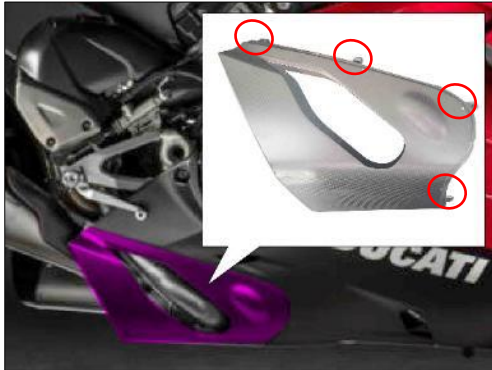
| no. | Symptom | Subject | Photo | Notes and Indications - Corrective action |
|---|--|---|---|--|
| 14 | <p><u>ONLY Superleggera V4</u></p> <p>Possible mismatch between the silencer covers and the side half fairings if the complete Akrapovic racing titanium exhaust system is installed</p> | Coupling of the silencer cover and side half fairings | | <p>We have received some isolated reports about an incorrect coupling between the silencer covers and the side half fairings in case the complete Akrapovic racing titanium exhaust system, supplied with the motorcycle, is installed. In fact, it is possible to find a misalignment between the mounting holes of the components.</p> <p>To improve this coupling, it is possible to slot-drill the 4 mounting holes of the silencer covers by using a column drill with a <u>6 mm drill bit</u> and setting a high rotation speed to prevent the fiber from flaking off.</p> |

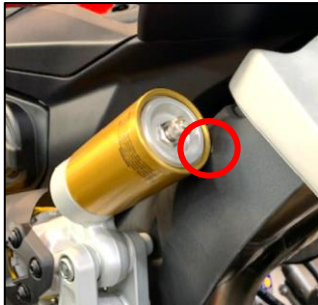
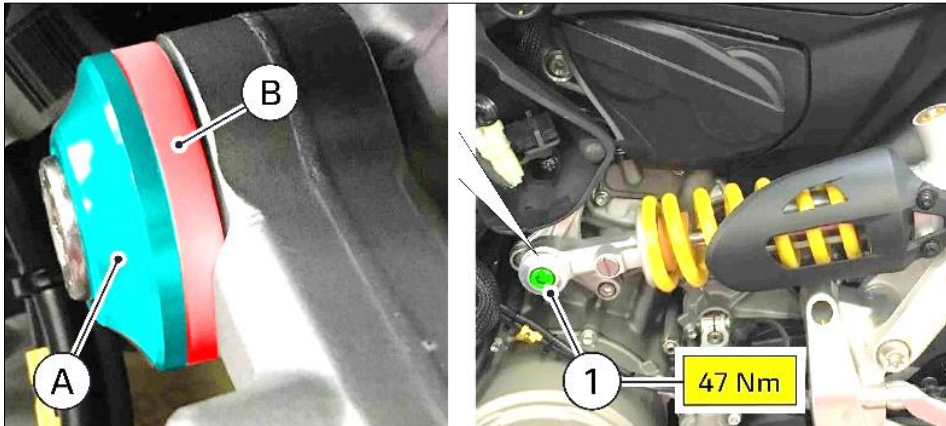
| no. | Symptom | Subject | Photo | Notes and Indications - Corrective action |
|---|---|---|--|--|
| 17 | <p><u>ONLY</u> <u>Panigale V2</u></p> <p>Possible contact of Sachs rear shock absorber reservoir with vertical head manifold heat guard</p> | Sachs rear shock absorber reservoir | | <p>We would like to inform you that starting from the frame number ZDMHAATW2MB003762, a spacer and a Teflon anti-rotation washer have been introduced at the front fixing screw of the shock absorber to prevent possible contact between the rear shock absorber reservoir and the vertical head manifold head guard. The contact results in a cosmetic defect only.</p> <p>In case of complaints from the Customer, it is possible to proceed with the installation of spacer part no. 7111D981AA (A) and washer part no. 7131E352A (B), as shown in the figure.</p> <p>We remind you to always apply the screw M10x45 (1) with Shell GADUS S2 V220 AD 2 grease and to tighten the screw to the new torque of 47 Nm (the previous tightening torque was 45 Nm).</p> <p>The components are available as spare parts and can be ordered.</p> |

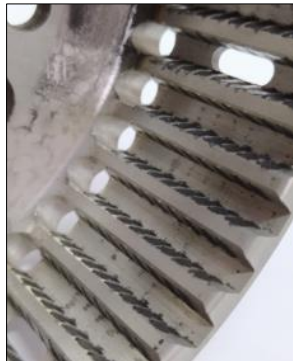
| no. | Symptom | Subject | Photo | Notes and Indications - Corrective action |
|---|---|---|--|--|
| 18 | <p><u>ONLY</u> <u>Panigale V4R</u></p> <p>Introduction of clutch housing with deep anodising</p> | Housing clutch | | <p>We have received some isolated reports of possible clutch slipping, due to clutch housing indentation, which does not allow the drive and driven plates to come back into contact with each other correctly. This phenomenon depends on the use of the motorcycle and the user, therefore for racing use we suggest replacing the plates approximately every 5000km,.</p> <p>We would like to inform you that the new clutch housing with deep anodizing part no. 19810671C, replacing the natural grey one, is available as a spare part; this treatment improves the reliability of the clutch housing reducing the damaging of the drive plates on its contact surface.</p> |

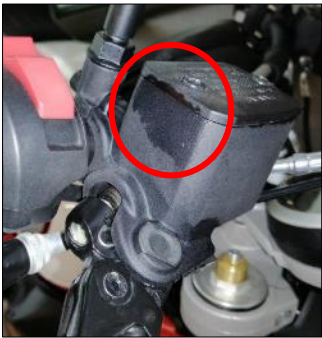
| no. | Symptom | Subject | Photo | Notes and Indications - Corrective action |
|---|---|---|--|--|
| 3 | <p><u>ONLY</u> Scrambler Desert Sled Scrambler ICON Scrambler Full Throttle Model Year 2019 - 2020</p> <p>Possible oozing out of brake fluid from reservoir cover</p> | Front brake fluid reservoir | | <p>We inform you that in case of complaints from Customers about a possible oozing out of front brake fluid from the relevant reservoir. This condition does not affect the operation of the brake system. It is possible to order the following kit part no. 89340331A as spare part to avoid the symptom in question.</p> <p>The kit part no. 89340331A includes:</p> <ul style="list-style-type: none"> • 2 screws (1) • Cover (2) • Membrane (3) • Baffle (3) |

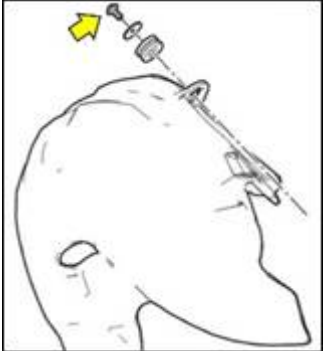
| no. | Symptom | Subject | Photo | Notes and Indications - Corrective action |
|---|---|---|---|---|
| 10 | Possible loosening of the screw retaining the heat guard | Screw 77244163B retaining the rear bank exhaust manifold heat guard | - | <p>We have received a few reports about a possible loosening of the screw retaining the rear bank exhaust manifold heat guard.</p> <p>The issue is being investigated, therefore, we kindly ask you to check the correct tightening of the above-mentioned screw (part no. 77244163B) when coming to the workshop (the prescribed tightening torque is 5 Nm ± 10%).</p> |

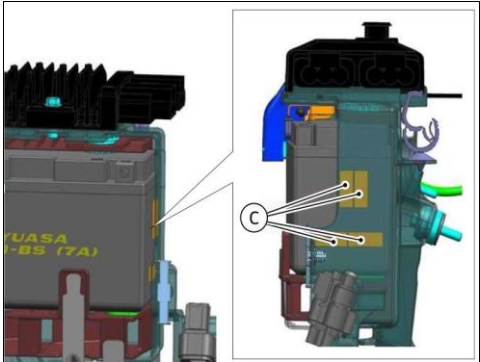
| no. | Symptom | Subject | Photo | Notes and Indications - Corrective action |
|---|---|---|--|---|
| 1 | <p><u>ONLY SuperSport 950 MY2021</u></p> <p>Contact between the battery and its support</p> | Battery | | <p>The ongoing tests on the product have revealed the possibility of contact between the battery and its support, which causes marks on both surfaces due to vibration. These marks do NOT affect the correct operation of the electric system and therefore of the vehicle.</p> <p>In order to prevent such marks, 4 adhesive pads (C) in rubber 9X23X1.4 part no. 86612791A have been introduced in the production line to be applied inside the battery support.</p> |
