Oil Leak on Cylinder Head Cover: Insert Microencapsulated Self-Locking Screw (166/21)

Model Lines: **Panamera (971)
Cayenne (9YA/9YB)**

Equipment: **8-cylinder Otto engine (engine type: CVD)**

Concerns: **Oil leak around the cylinder head cover**

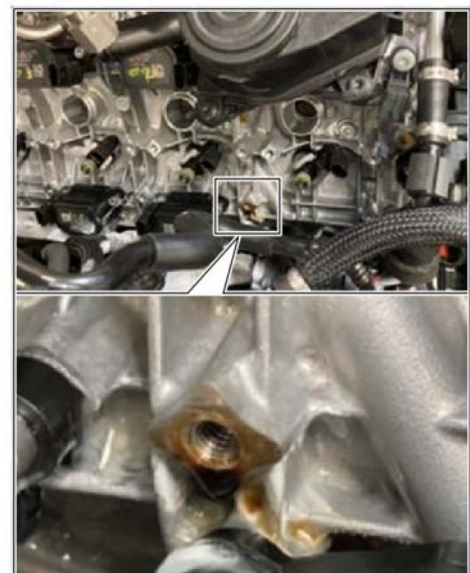
The measure described here relates to a potential oil leak at the screws shown on the cylinder head cover. If the oil leak occurs at another location, the oil leak must be found and remedied. This Technical Information (TI) does not apply in this case.

Example of an oil leak

Action required: Clean the affected area thoroughly and replace the affected screws and adjacent screws with micro-self-locking screws.
