# Technical Service Bulletin

**90 Instrument cluster: the Audi virtual cockpit displays a colorful vertical line (pixel error)**  
**90 21 31 2064983/2 December 22, 2021. Supersedes Technical Service Bulletin Group 90 number 21-22 dated November 9, 2021 for reasons listed below.**

Model(s)	Year	VIN Range	Vehicle-Specific Equipment
A4/A5/A6/A7/A8/Q5/Q7/Q8	2021 – 2022	All	Audi virtual cockpit Gen2+

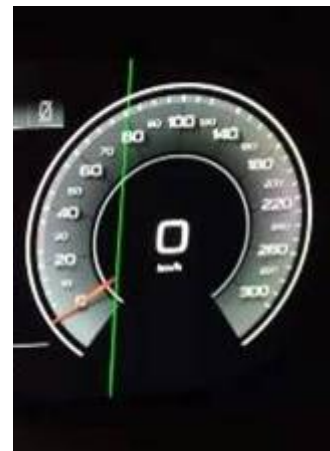
- A red, green, or blue continuous vertical line is displayed on the instrument cluster (pixel fault) (Figures 1 - 2).
- The line may be vertical or horizontal.

*Figure 1. The vertical line through the instrument cluster display.*

There is a hardware issue in Audi virtual cockpit.

1. Please take photos of the area of concern and upload them into DOC-IT with the repair order. Photos should:
  - Have a date stamp and VIN reference.
  - Be taken in focus and with sufficient light.
2. Please replace the instrument cluster, J285 (address word 0017) according to the Elsa Repair Manual. The replacement part should have a production date of Sep 1, 2021 or newer.

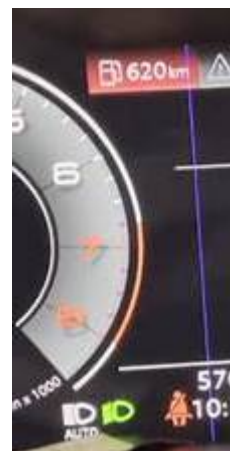
*Figure 2. The vertical line through the instrument cluster display.*
