**ELECTRIC MOTOR SOUND FROM THE AUDIO SYSTEM IS TOO LOUD**

**Bulletin No.: 30-002/21**

**Last Issued : 12/20/2021**

2022 MX-30 with VINS lower than JM1DR\*\*B\*\*\*100475 (produced before October 20, 2021)

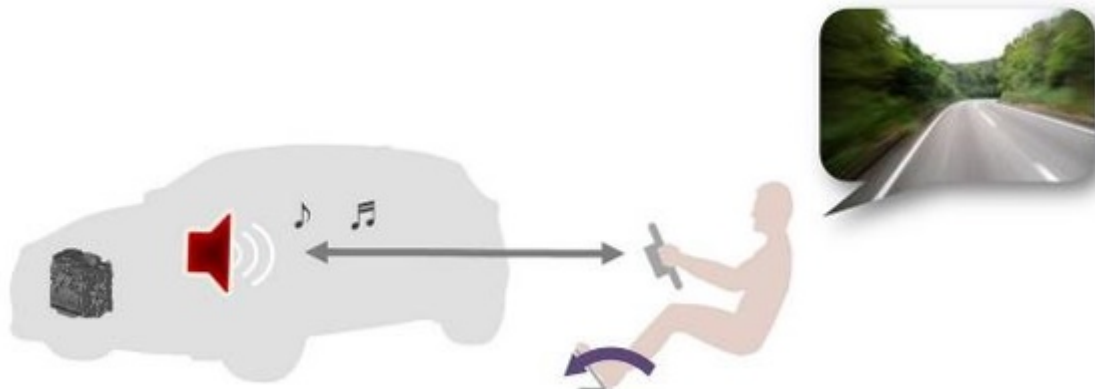
Some customers may complain that the electric motor sound from the audio system is too loud. An electronically generated sound is provided through the audio system (instead of an engine sound) to inform the driver of the vehicle's behavior such as level and changes of motor torque.

The electric motor sound can be annoying to some customers, therefore a way to disable the sound has been created. The control software of the PCM has been modified to add a function to disable/enable the sound.
