Instrument Cluster Reprogramming (MID
140)
GU, GR

PI0889 Differential Lock Engagement Status Alarm Update (MID 140)

(December 2021)

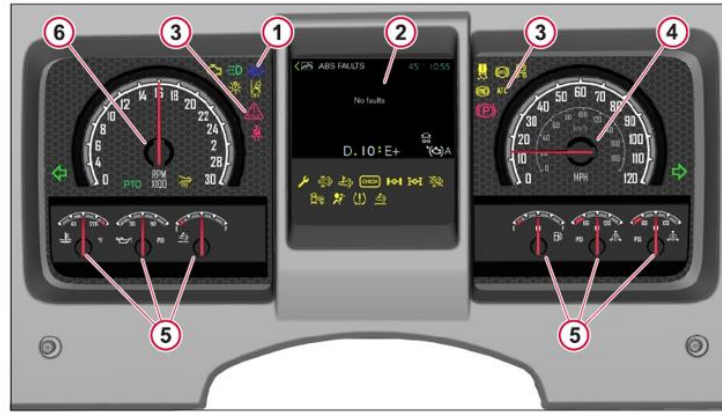
Current Software

Diff-Lock Engaged: (Popup + audible + Icon) Begins

Popup = 30sec

Audible = 5sec

Icon = Continuous

Diff-Lock Disengaged: (Popup + audible + Icon) End

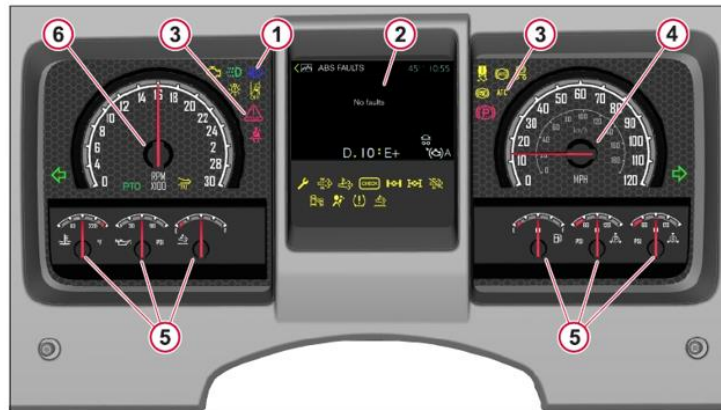
New software

Diff-Lock Engaged: (Popup + audible + Icon) begins

**Popup = Continuous, but can be dismissed.
If dismissed will return > 30sec**

Audible = follows popup

Icon = continuous

Diff-Lock Disengaged: (Popup + audible + Icon) ends

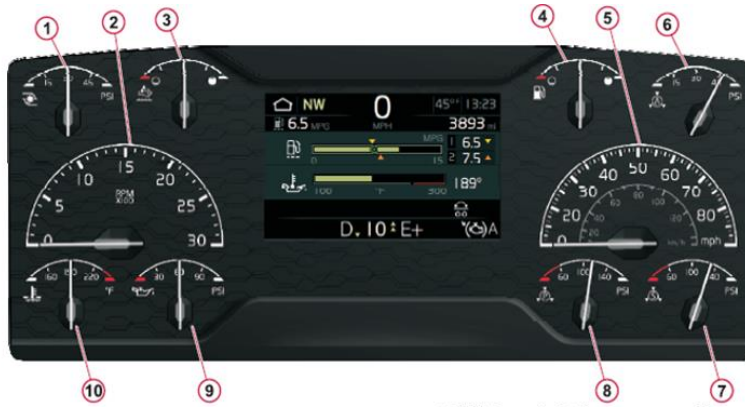
Current Software

Diff-Lock Engaged: (Popup + audible + Switch Display) begins

Diff-Lock Disengaged: (Popup + audible + Switch Display) End

Popup = 5sec

Buzzer = 5sec

Switch Display = Continuous

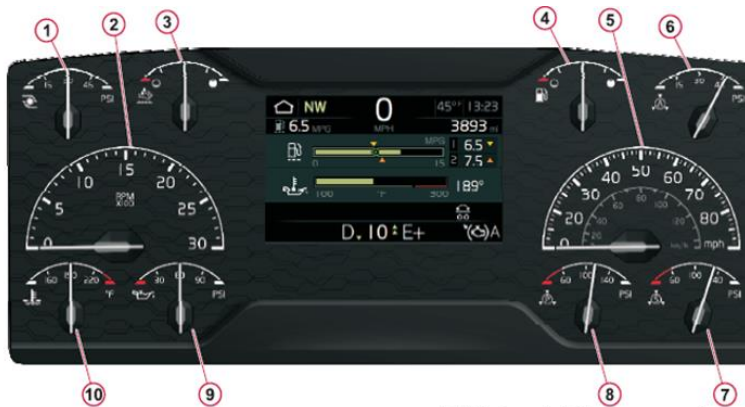
New Software

Diff-Lock Engaged: (Popup + audible + Switch Display) begins

Diff-Lock Disengaged: (Popup + audible + Switch Display) End

Popup = Continuous, can be dismissed by operator

Buzzer = Continuous

Switch Display = Continuous
