# Technical product information

<b>Topic</b>	W12 TSI - Engine MIL light illuminated with numerous DTC's within 0001 including - P032700 and/or P033200
<b>Market area</b>	Russische Föderation (5RU),Australia E04 Bentley rest Asia and Australia (6E04),China 796 VW Import Comp. Ltd (Vico), Beijing (6796),Germany E02 Bentley rest Europe (6E02),Japan E03 Bentley Japan (6E03),Korea, (South) E08 Bentley South Korea (6E08),United Arab Emirates E06 Bentley Middle East and Africa (6E06),United Kingdom E01 Bentley UK (6E01),United States E05 Bentley USA and rest America (6E05)
<b>Brand</b>	Bentley
<b>Transaction No.</b>	2065398/1
<b>Level</b>	EH
<b>Status</b>	Approval
<b>Release date</b>

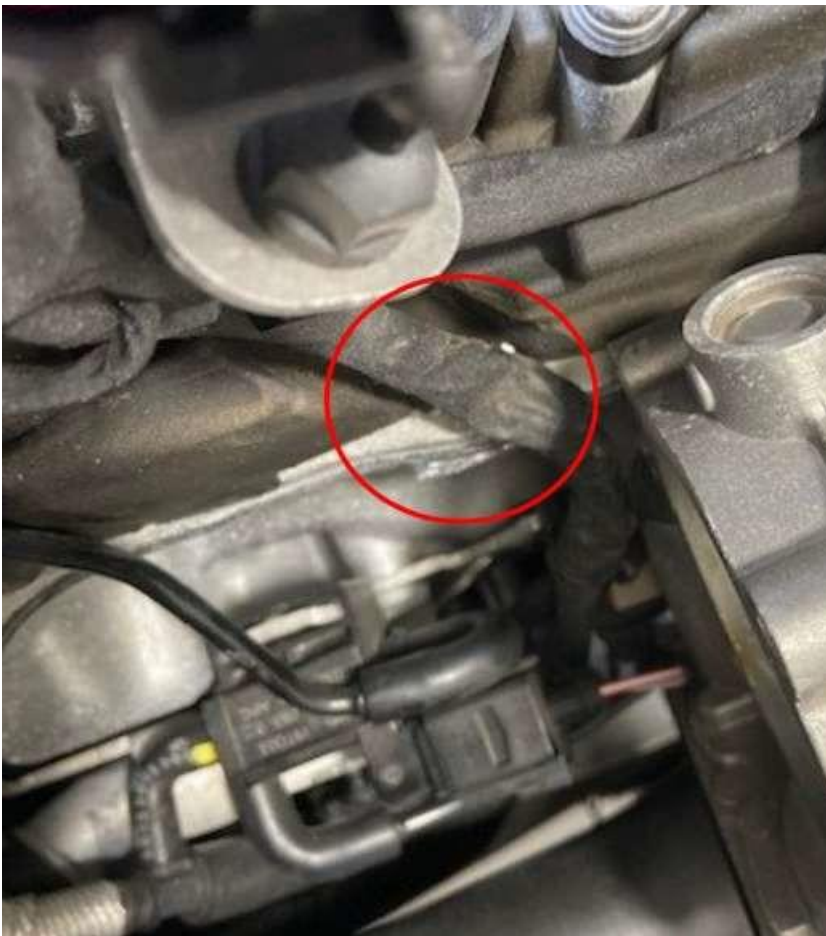
The symptom/issue can relate to a section of the engine wiring harness which has been damaged due to contact with the Bank 1 cylinder head as shown in Figure 1

- The issue to date has only been evident on Bank 1 - within address 0001 (Engine control module 1)
- NOTE: in the event the DTC's or symptoms relate to Bank 2, please raise a DISS query and await feedback before conducting any further work

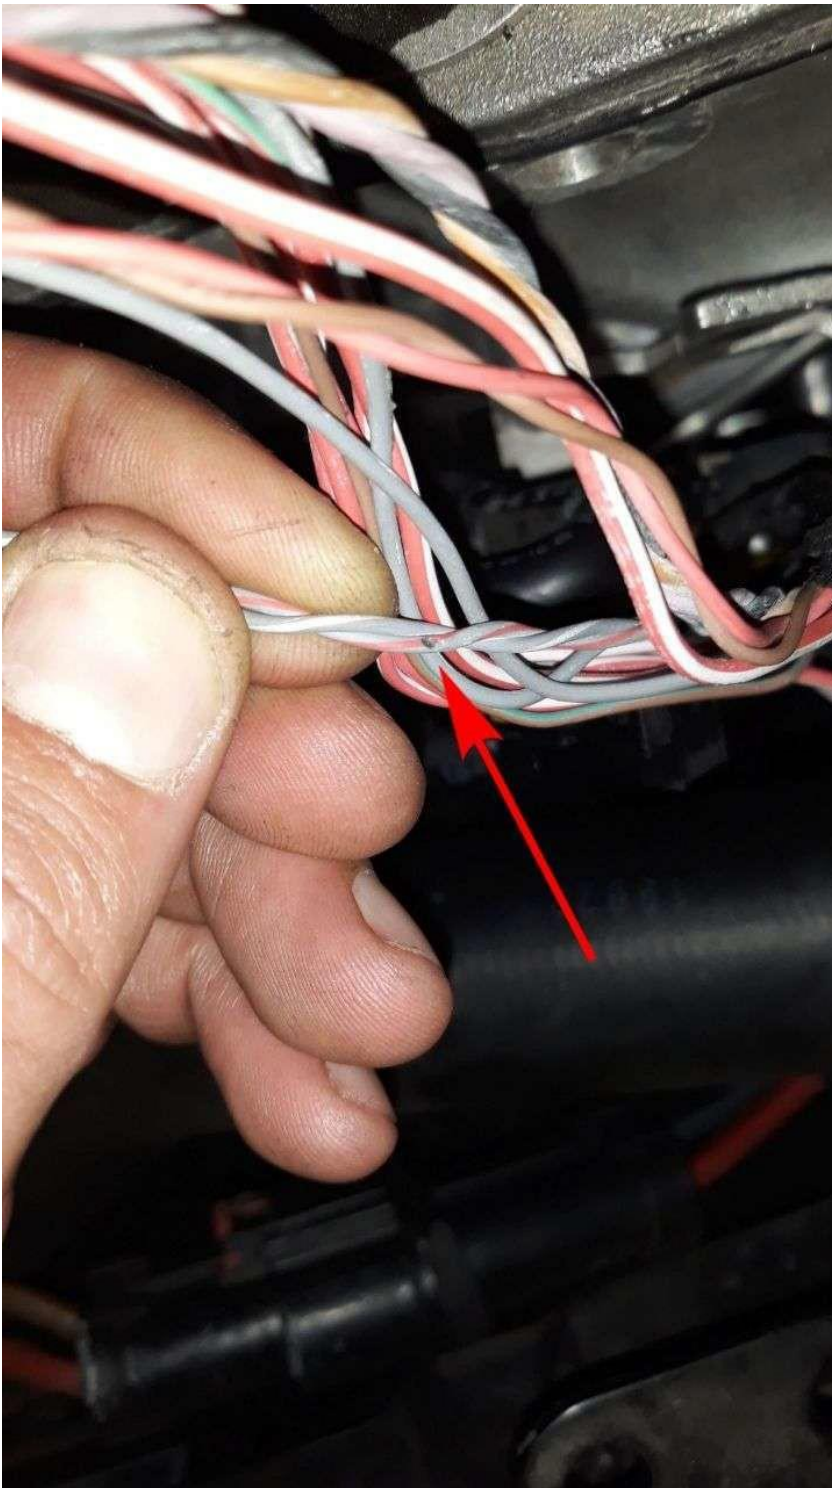
4) The example shown in Figure 3 shows an example of damaged wiring - Referring to Rep.Gr 97 to repair the damaged wiring

5) Wrap/insulate the repaired harness using suitable harness tape
