SERVICE BULLETIN

EL21-018
 NTB21-103
 November 5, 2021

AUTOMATIC BACK DOOR LOCK AND CLOSE SWITCH ASSEMBLY LOOSE OR FALLS OUT

APPLIED VEHICLES: 2021 Rogue (T33) **APPLIED VINS:** VINs starting with **5N1**

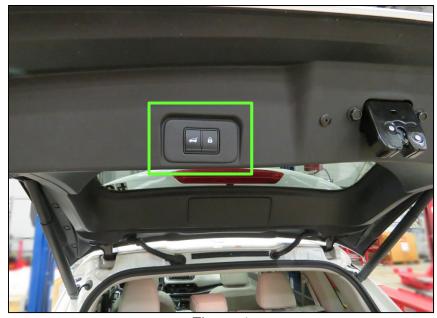
Figure 1

The customer states that the Automatic Back Door Lock and Close Switch Assembly is loose or has fallen out of the back door (Figure 1).

Remove a small amout of material from the back door, around the inside of the switch opening.
