# Technical product information

<b>Topic</b>	V8 Kovomo - Engine misfires - Engine management light illuminated within the DIP
<b>Market area</b>	Russische Föderation (5RU),Australia E04 Bentley rest Asia and Australia (6E04),China 796 VW Import Comp. Ltd (Vico), Beijing (6796),Germany E02 Bentley rest Europe (6E02),Japan E03 Bentley Japan (6E03),Korea, (South) E08 Bentley South Korea (6E08),United Arab Emirates E06 Bentley Middle East and Africa (6E06),United Kingdom E01 Bentley UK (6E01),United States E05 Bentley USA and rest America (6E05)
<b>Brand</b>	Bentley
<b>Transaction No.</b>	2064776/2
<b>Level</b>	EH
<b>Status</b>	Approval
<b>Release date</b>

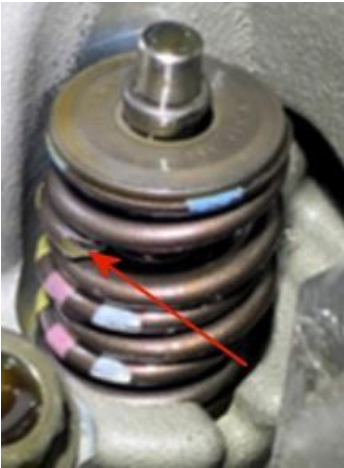
- Referring to Figure 1 - Take clear photos of the broken valve spring (from the affected cylinder head only)

VERY IMPORTANT: Ensure the photos show the location in which the valve spring is broken (ARROW) the various paint markings should also be captured

- Attach all photos to the open DISS query
- Attach the new replacement engine number to the DISS query
