AN21-023

ITB21-026

SOFTWARE UPDATE FOR CLOCK INCORRECT

APPLIED VEHICLES: 2020-2022 QX50 (J55)
2022 QX55 (FJ55)
2020-2022 Q50 (V37)
2020-2022 Q60 (CV37)

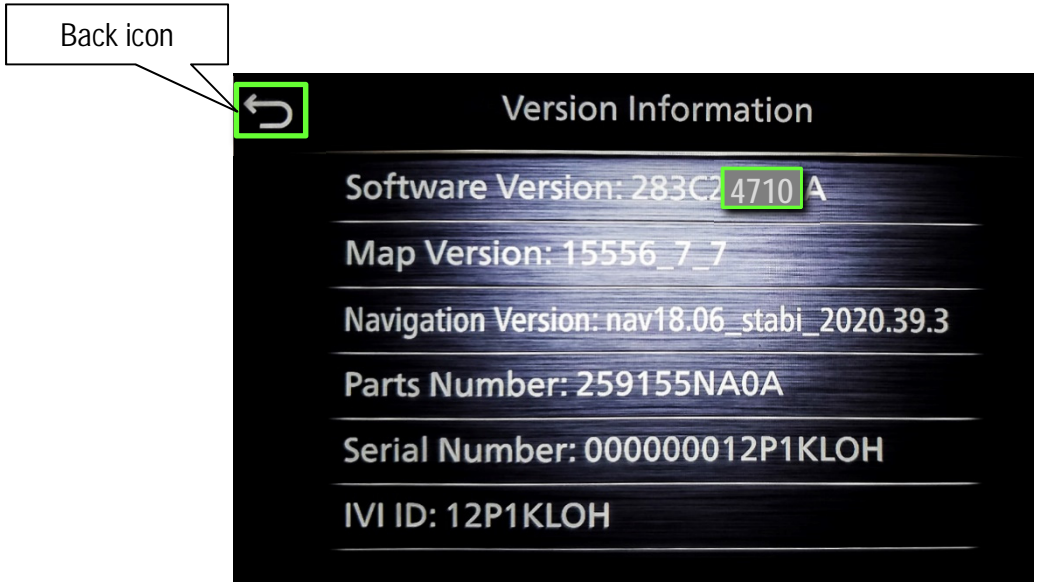
Figure 5

4. Confirm the **Software Version** number (Figure 5).

- If the Software Version (digits 6-9 as shown in Figure 5) is **lower** than xxxxx**4710**x, select the back icon and continue to step 5 on the next page.
- If the Software Version is xxxxx**4710**x or higher (digits 6-9), select the back button; this bulletin does not apply. Refer to ASIST for further diagnostic information.

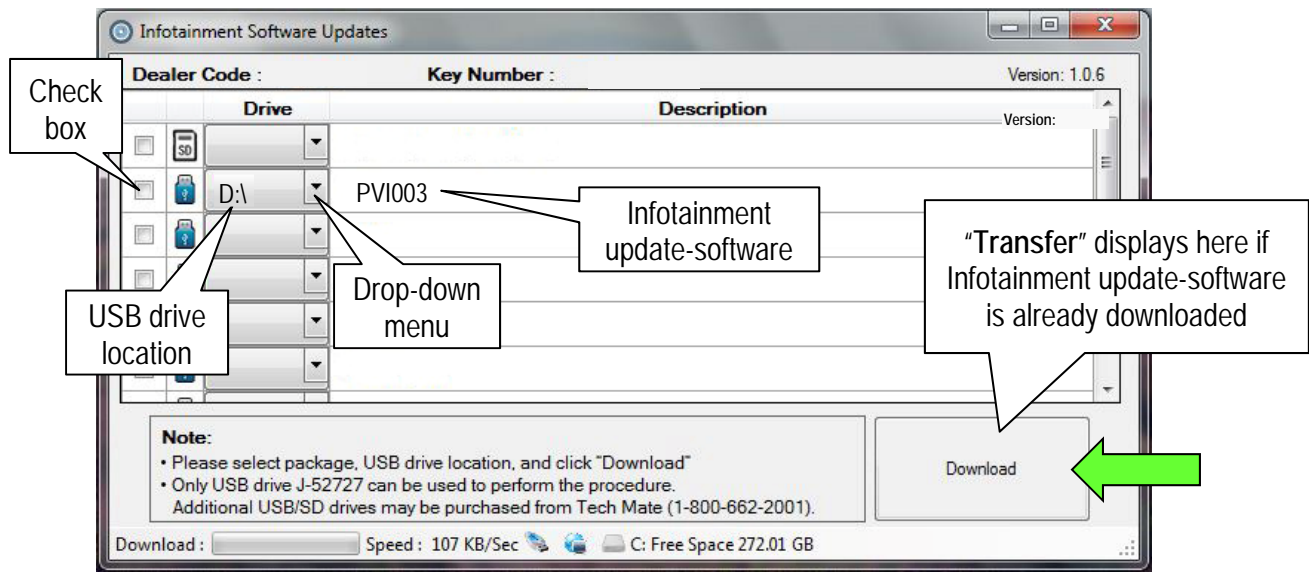
Figure 7

8. Select the check box next to the **PVI003** infotainment update-software (Figure 7).
 - If the **PVI003** infotainment update-software has already been downloaded, “**Transfer**” will be displayed instead of **Download** when the infotainment software update box is checked.
9. Use the drop-down menu and select the location of the USB drive that was inserted in step 5 on page 5.

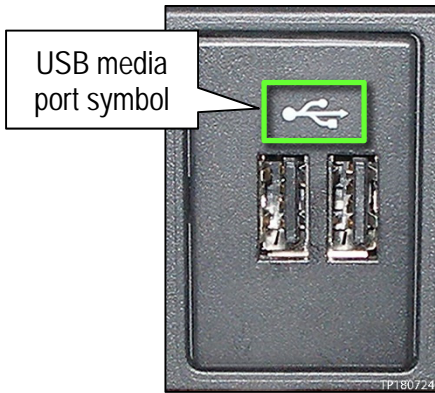
Figure 11

16. Insert the USB drive with infotainment update-software into the vehicle's USB media port (see Figure 11).
- Do not remove the USB drive during the update to the vehicle until instructed to.

Do not insert the USB drive into a charging port. If used, the update-software and/or USB drive may become damaged. Only insert the USB drive in a USB media port.

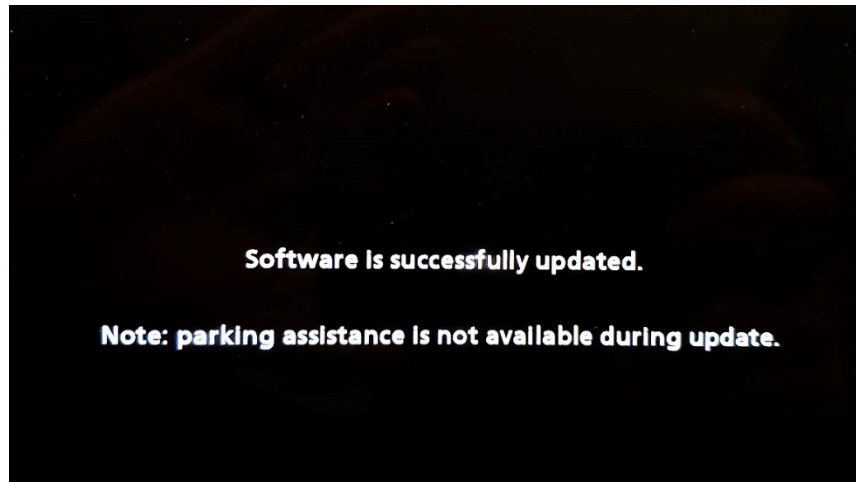
Figure 14

18. Once the update is complete (Figure 14), remove the USB drive; the system will reboot (restart).
HINT: The system will not reboot until the USB drive is removed.

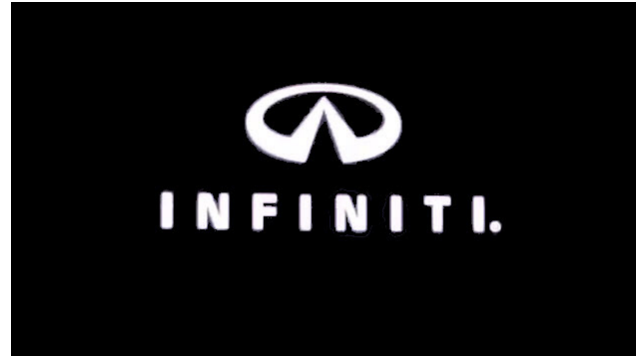
Figure 16

23. Turn the ignition ON (engine OFF) and wait for the Infiniti logo to appear (Figure 16).
 - If the Infiniti logo does not appear (this might take up to 30 seconds), start over from step 20.

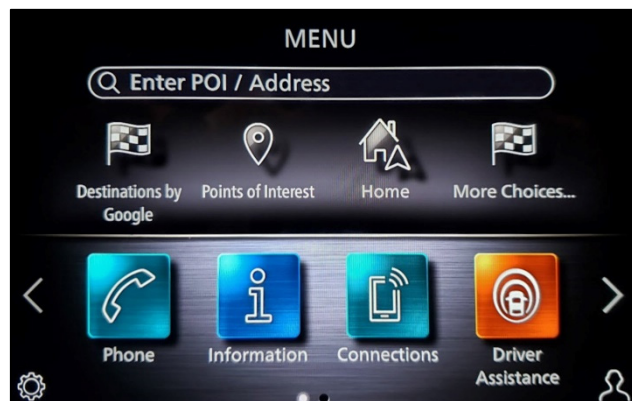
24. After the Infiniti logo appears, wait about 1 minute.
 - The MENU (Home) screen in Figure 17 will be displayed.
