Subject Hybrid Radio - Error Message Pop-ups		Market USA
Service Category Audio/Visual/Telematics	Section Cellular Communication	
Applicability 2022 Tundra

2022	Tundra
------	--------

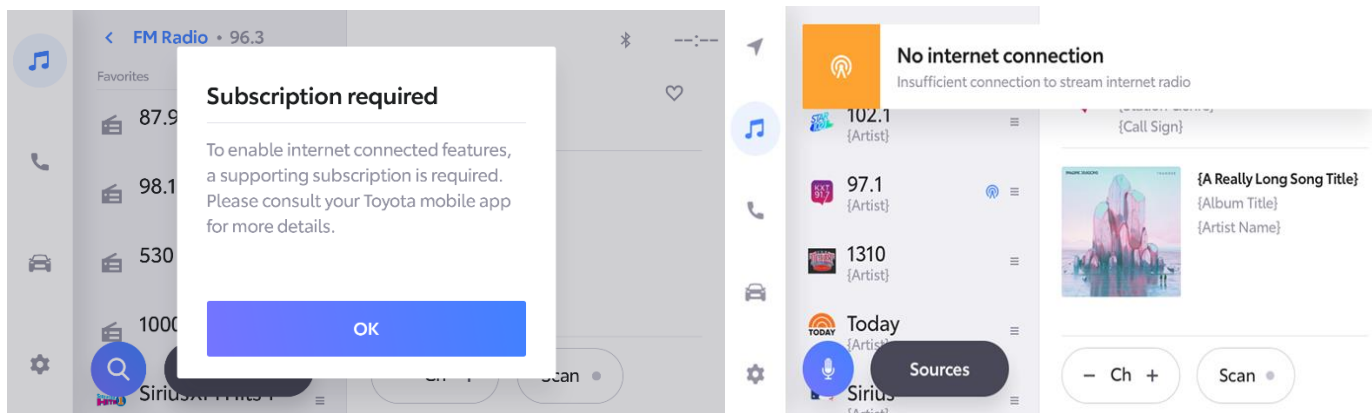
Some 2022MY Tundra vehicles may experience one of the following pop-up messages if “Hybrid radio” has been enabled. Please follow the steps below to correct the condition.
