Subject <b>Hybrid Radio - Error Message Pop-ups</b>		Market <b>USA</b>
Service Category <b>Audio/Visual/Telematics</b>	Section <b>Cellular Communication</b>	
Applicability <b>2022 Tundra</b>

2022	Tundra
------	--------

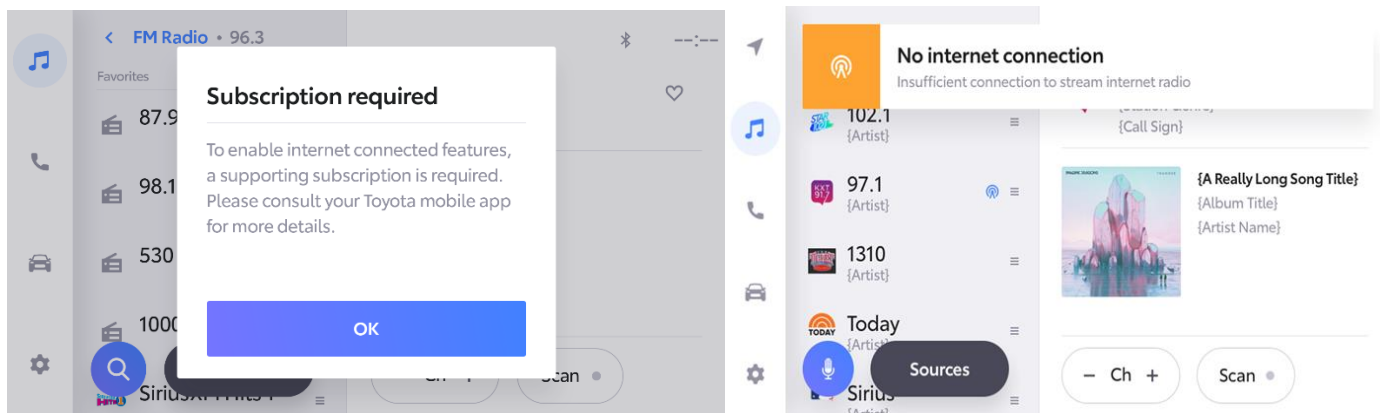
Some 2022MY Tundra vehicles may experience one of the following pop-up messages if “Hybrid radio” has been enabled. Please follow the steps below to correct the condition.
