# Technical Service Bulletin

## 35 Oil leak from the transmission input shaft

35 22 41 2051719/4 January 7, 2022. Supersedes Technical Service Bulletin Group 35 number 18-36 dated December 17, 2018 for reasons listed below.

Model(s)	Year	VIN Range	Vehicle-Specific Equipment
A3 e-tron	2016 – 2018	All	Not Applicable

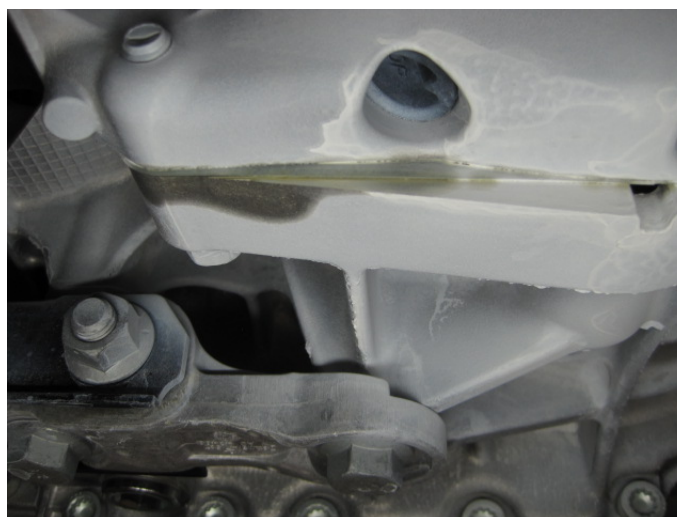
- The customer concern can be duplicated.  
The oil leak can be traced to the transmission at the bell housing (Figure 1) and the input shaft (Figure 2).

Figure 1. Oil leaking from the bell housing.

2. Replace the oil seal according to the repair manual. Located in ELSA under *Drivetrain >> 6-Speed S tronic Transmission ODD >> 30 Clutch >> Input Shaft Seal, Replacing* (Figure 3)

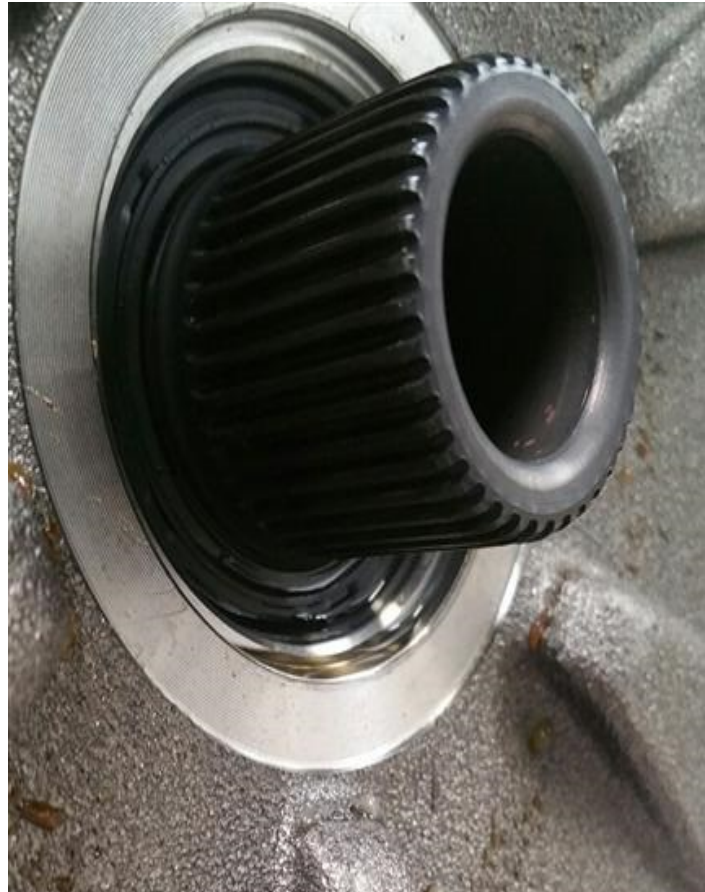
*Figure 2. Oil leak at the input shaft.*
